## The Ruskin Building

# 4.1 Building Condition

## 4.1 Building Condition

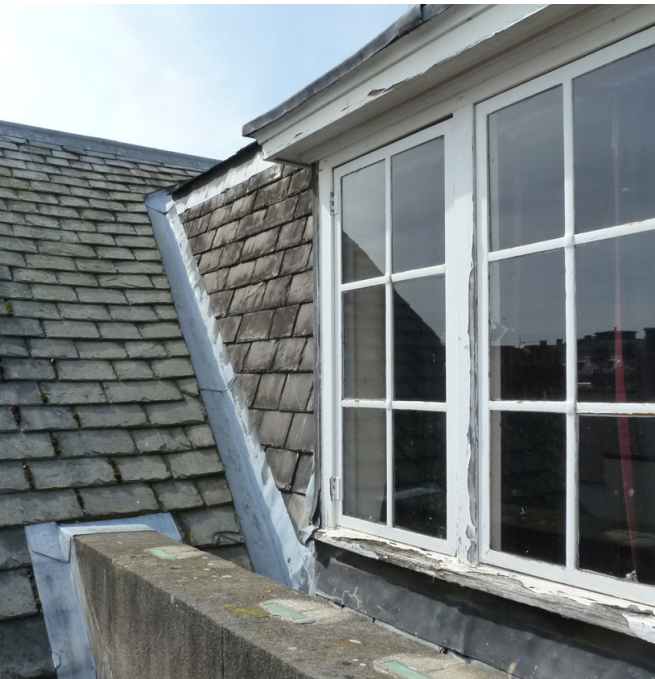
Tucked in behind the parapets and chimney stacks the roof over 1913 and 1936 building is clad in slate with lead flashings. The windows are metal single glazed and in many cases rotten and leaking. The roof in general is in need of serious maintenance and repairs.

Roof Gutter, Parapet and Window

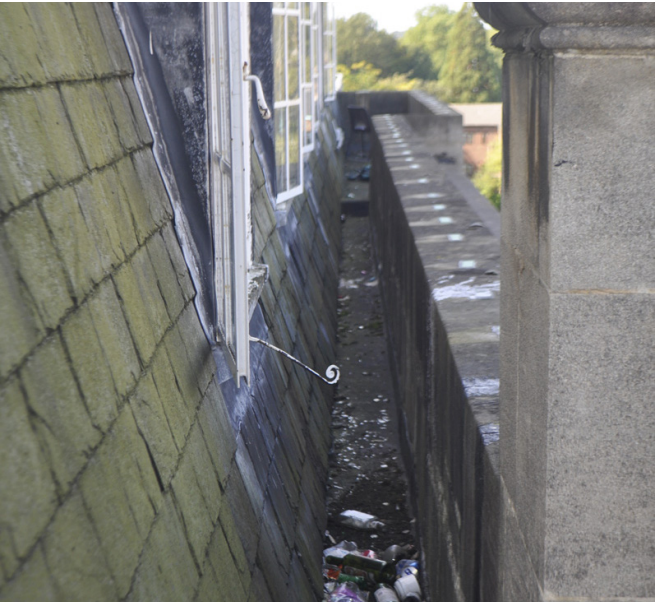
Roof Gutter behind Parapet

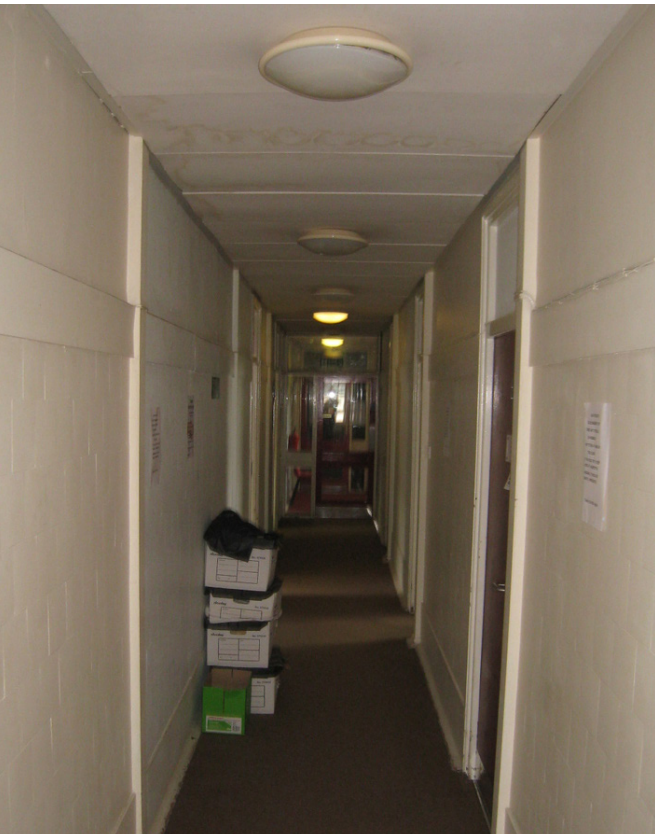
Internally the building is a maze of interconnected corridors and with staircases and ramps. As such five sets of stairs have to be navigated when going from one side of the site to the other.

Typical Corridor

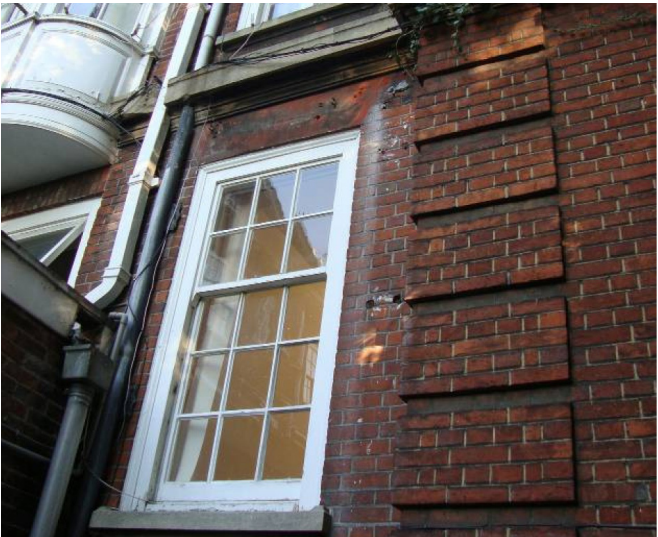
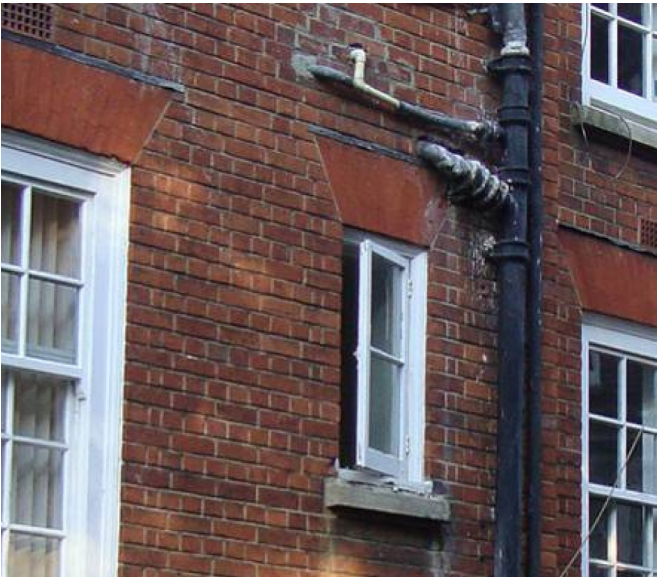
Externally the stone and brickwork is in a good condition. There are minor cracks within the eastern facade of the bearing stones around the window openings. The stone coping and three stone pediments are in a fair condition though there has been some weathering at points due to water penetration; this has also resulted in some vegetation growth along the joints. Locally where the stone work has been exposed the stone is worn and subject to minor spalling.

There is some evidence of efflorescence in a number of locations within the brickwork. The facades have also been exposed to patch repairs particularly prevalent on the south and eastern facade of the quad; this is due to poor maintenance of the downpipes along the facade. This is emphasised along the clear interface between the 1913 and the 1930s extension.

Exterior Windows

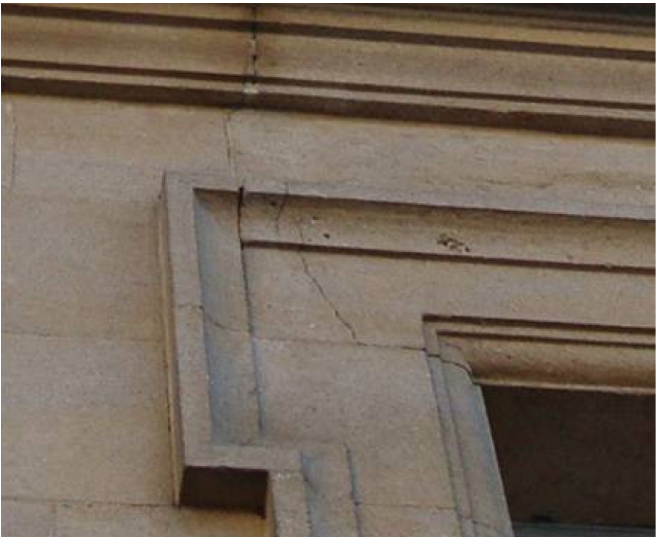
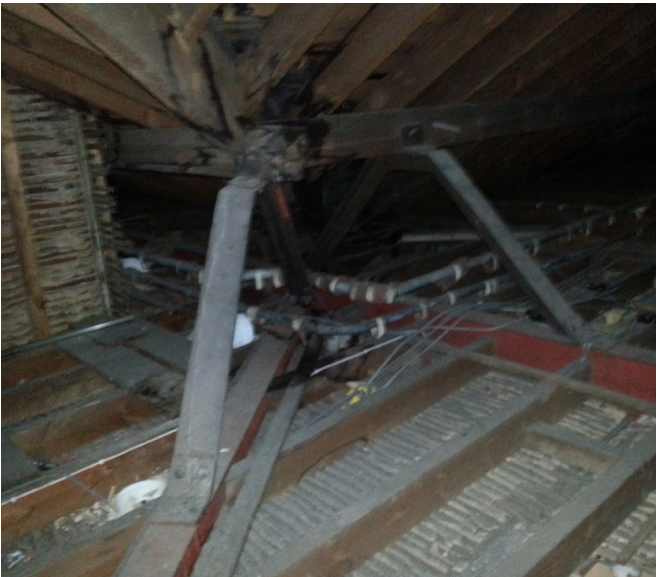
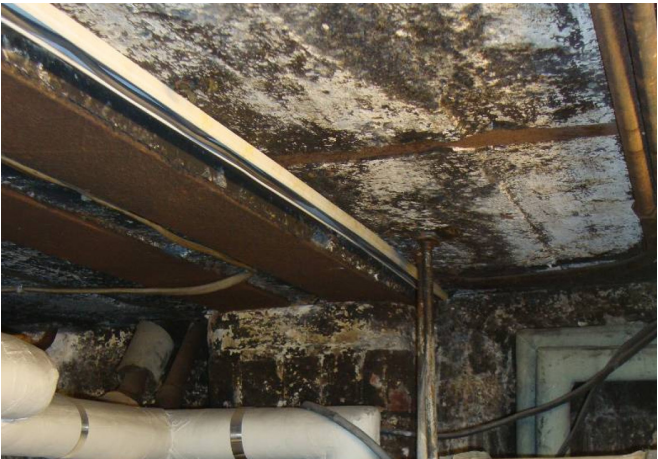
Internally there are a number of down stand beams and a masonry corbel beam, where the primary steel beams are exposed there is uniform rusting. The internal arrangement of the floor levels, particularly around the porter lodge has been modified over the years, in order to accommodate the ventilation of the substation. There is some water ingress damage on the timber rafters supporting the mansard roof.

Floor Construction

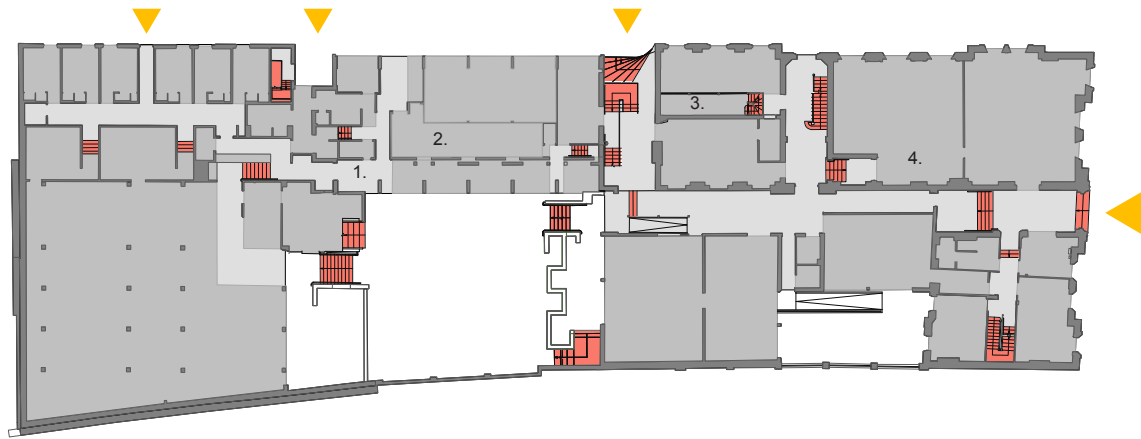
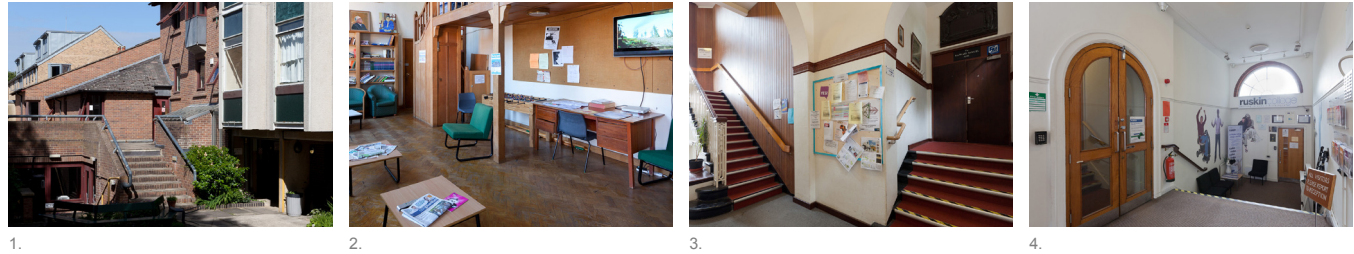
The principle access is via Walton Street, however there are three additional stepped entrances which create problems of accessibility and pose a security risk.

Existing Staircases at Ground Floor Level

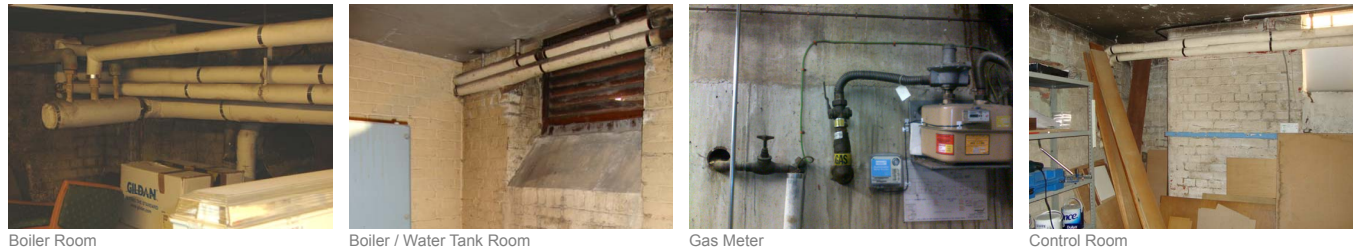
Existing Antiquated Mechanical Systems
