EXETER COLLEGE OXFORD

A New Quad at Walton Street
Arboricultural Impact Assessment

March 2013

ROOT TRIAL PIT
INVESTIGATION
ASSESSMENT

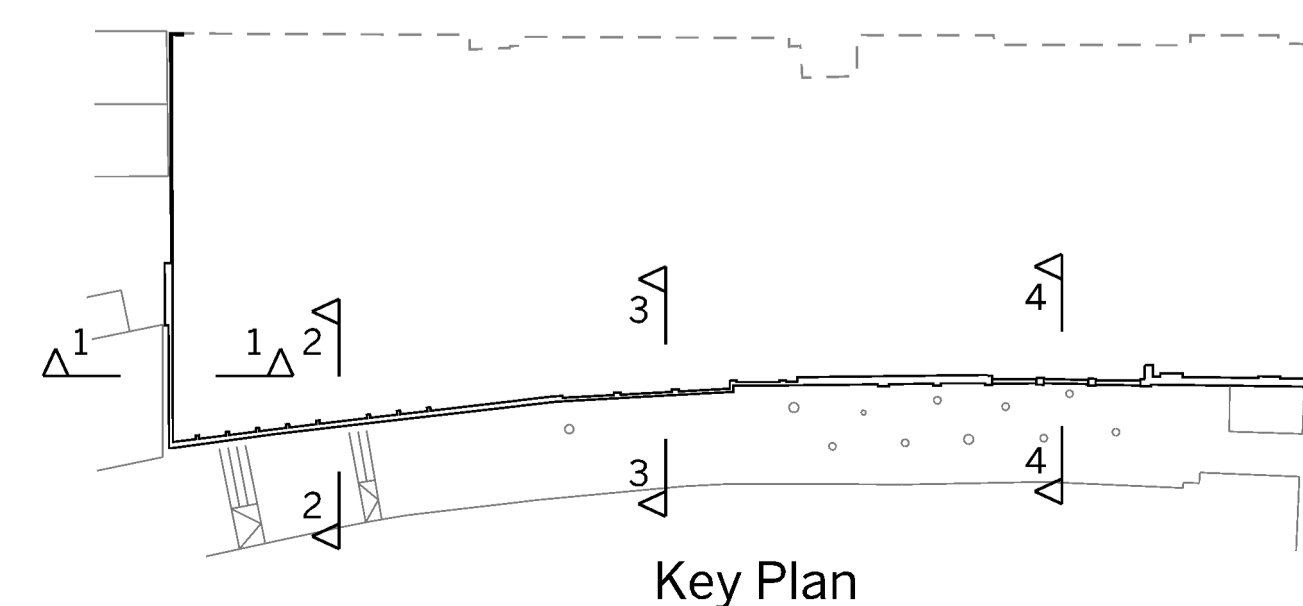
Title:
 Existing Perimeter Wall Sections

The eastern end of the Ruskin College building was built in 1912 and the eastern end of southern boundary wall formed part of this construction. The boundary wall was extended west in the 1930's. The boundary wall has a foundation depth of approx 1.5m below existing ground level, detailed sections through the wall are provided on (SK)016 included, section 3 & section 4 are relevant to the Holm Oaks.

Notes:
 Refer to (SK) 015 for location plan.
 All sections shown are indicative only and require confirmation on site through opening up works.

- 3.1.1 It has been documented within the site investigation statement that the eastern section of the boundary wall was built in 1912 with the wall extended west in the 1930's. Site investigation works have recorded the boundary wall of having a foundation depth of 1.5m below the existing ground levels (Appendix 3).

- 4.1.3 Built structures have the capability of influencing tree roots and the existing boundary wall foundations of 1.5m are considered to be of an exceptional depth. Tree roots are opportunistic and where conditions permit, such as soft ground areas roots will be laid down preferentially. In addition tree roots will exploit defects in structures where it is considered conducive for root growth. Given the age of the boundary wall it is not unrealistic to assume that cracks and fissures are present within the walls foundations. Fibrous roots can also descend to depths greater than 600mm and then can re-ascend to the upper layers within a soil were conditions permit. During the site investigation works no live Quercus roots have been recorded beyond a depth of 300mm suggesting that the identified Quercus roots are not 'circumventing' under the boundary wall foundations and re-emerging within the Quod areas.

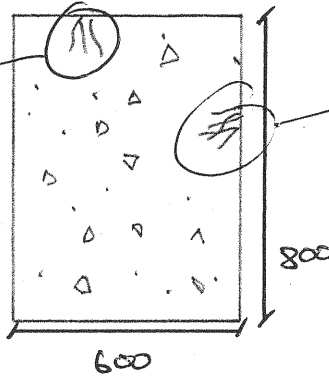
NUMEROUS FOOTLETS
3-7mm Ø from
0.1m to 0.3m

FOOTLETS
1-6mm Ø
@ 0.2m

Remarks:
All dimensions in millimetres
Sides of trial pit unstable during excavation

- 3.2.2 The August 2012 investigations recorded numerous rootlets of 1mm – 7mm in diameter at depths of up to 200mm in TP5. From the samples taken from TP5 one root (sample size not recorded) was found to be of Quercus origin (Oak family) with a further 4 roots (sample size not recorded) not examined in detail but appearing similar (Appendix 4).

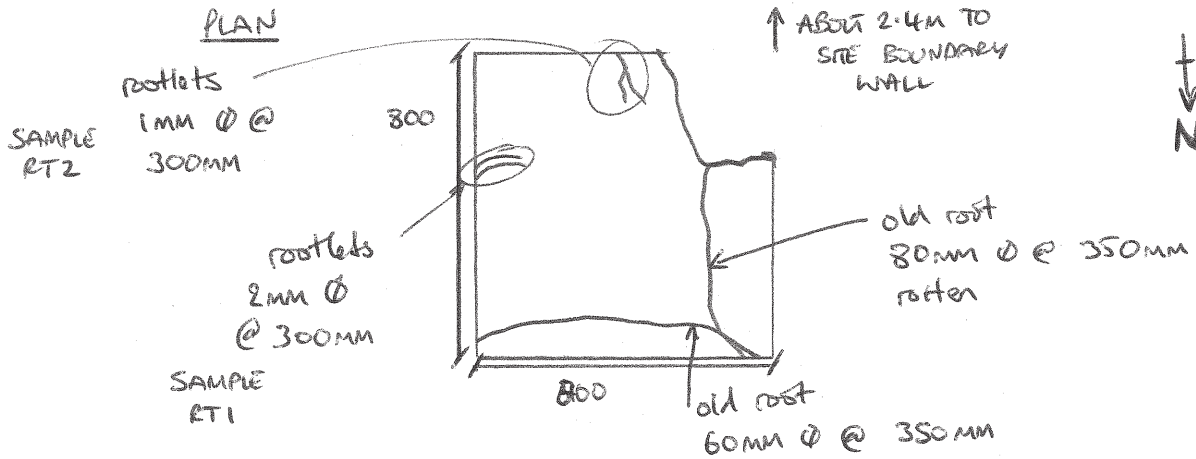
PLAN

TYPICAL SECTION

All dimensions in millimetres
