EXETER
COLLEGE
OXFORD

A New Quad at Walton Street
Building Appraisal

March 2013

**Exeter College. Oxford, Walton Street Quadrangle
1913 Ruskin Building - Building Appraisal**

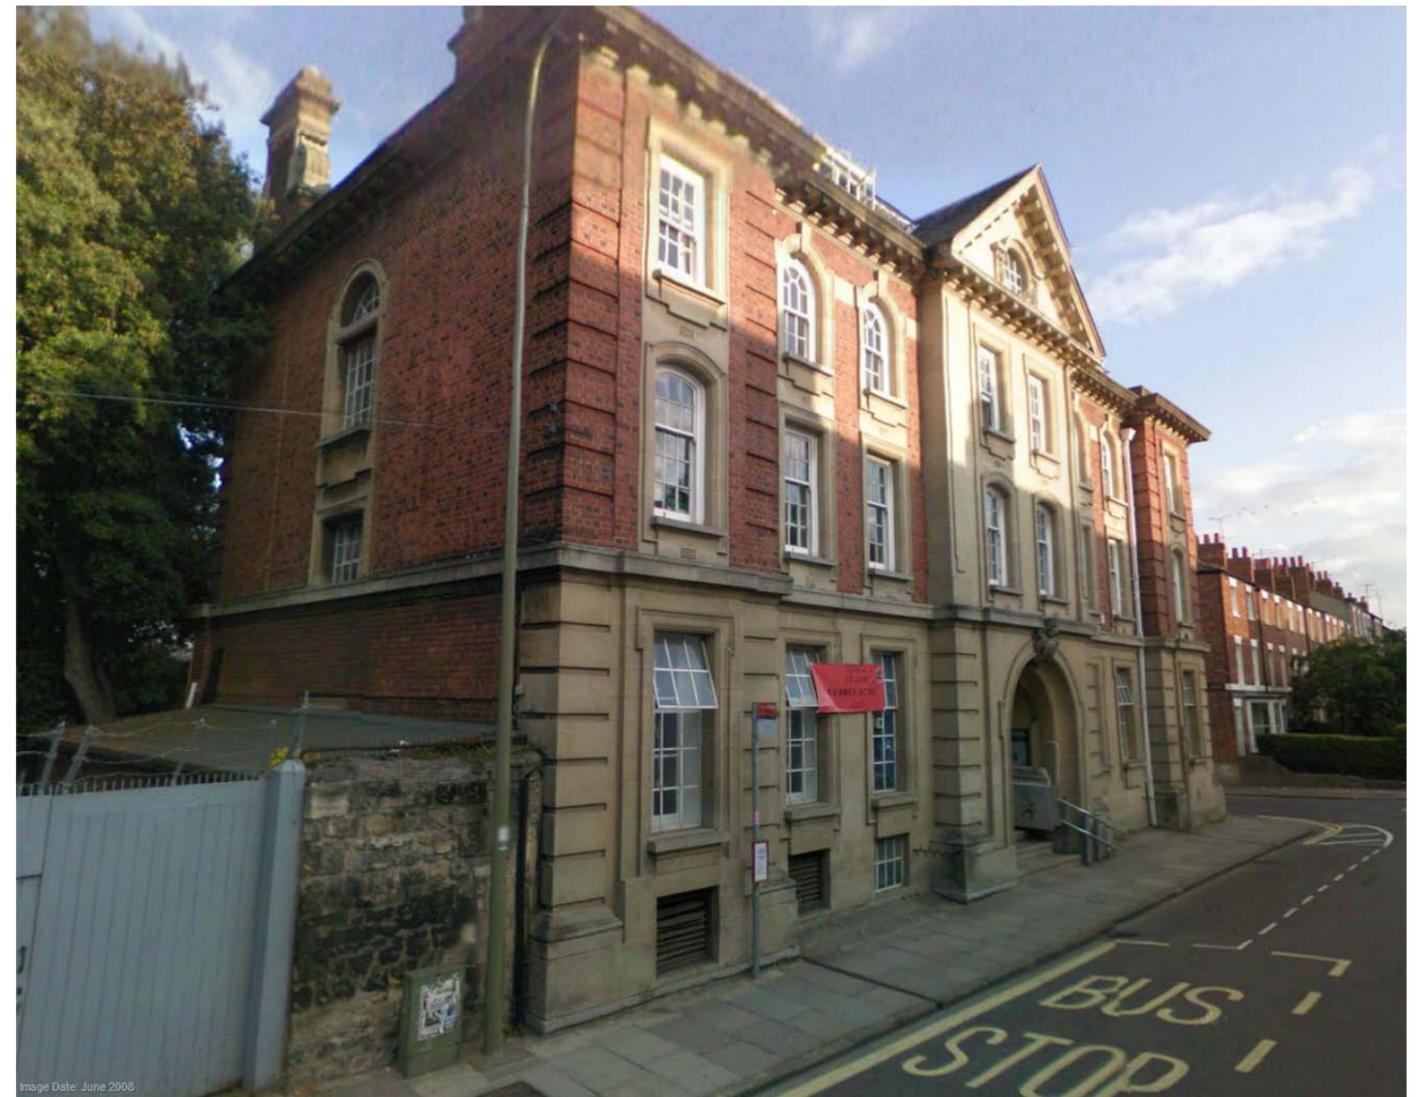
Figure 1 1913 Ruskin Building fronting Walton Street

Construction began on the original building in 1913 and the college was opened in February 1913 (see Figure 1 1913 Ruskin Building) The building is an L-Shape but the original plans were to construct a U shaped building around a quadrangle which was to be opened to the south. Although the building was extended a number of times between the 1930's and the 1980's the full U shape was never realised.

The 1913 structure is formed of load bearing brickwork façade walls partly faced in stone which support floor beams which span between external walls and lines of internal steel posts concealed within corridor walls. There are a number of loadbearing internal walls primarily in the front portion of the block which contain chimney flues.

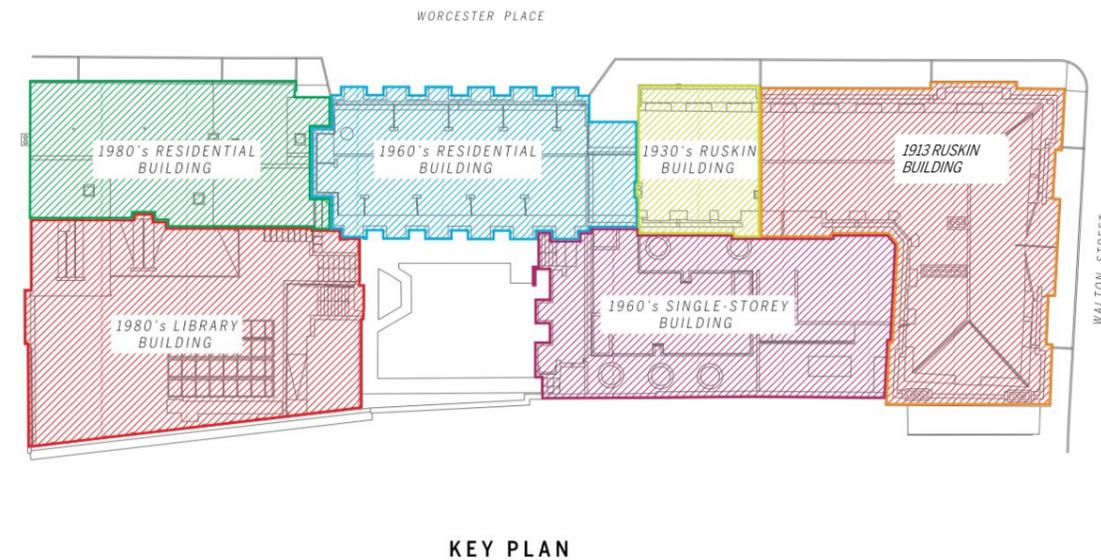
KEY PLAN
Figure 2 Key plan showing age of building structures

Figure 2 shows the age of building structures on the site.

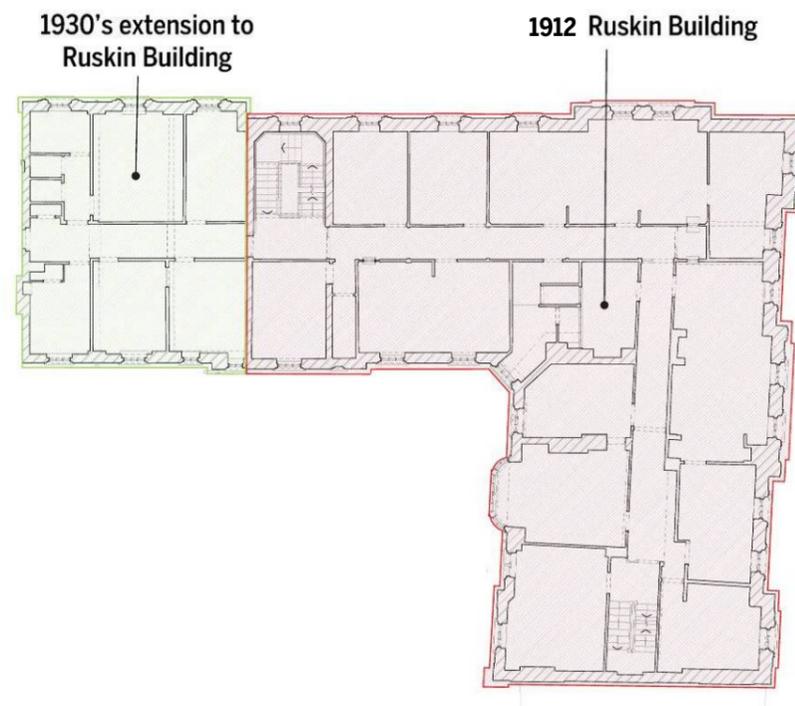
Figure 3 Ruskin Extension

The L-shaped building was the first phase of what was intended to be a U-shaped structure which was to sit around one end of a quadrangle. In the 1930's the northern wing of the building was extended to the west (see Figure 3).

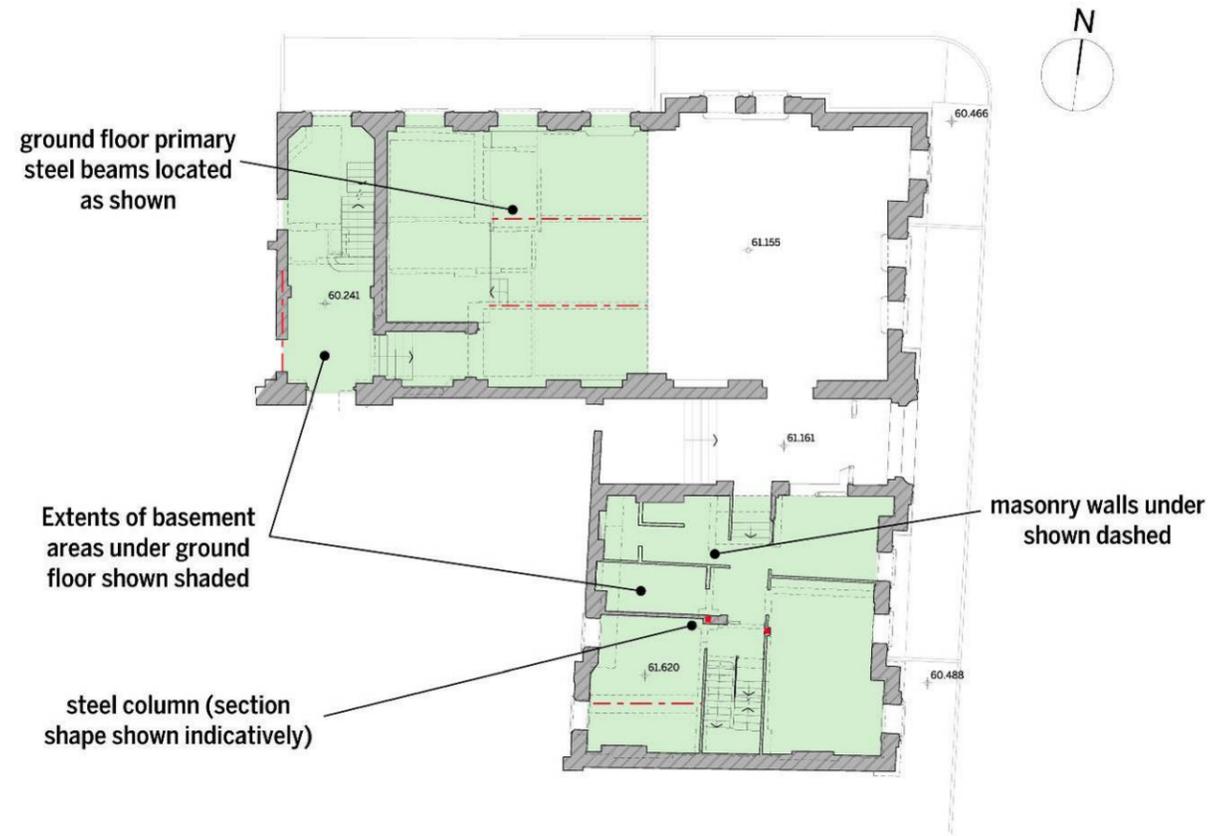
Figure 4 Ground Floor Structural Arrangement

As the basement areas below only partially cover the footprint of the building, the ground floor construction varies (see Figure 4).

The ground floor structure above basement areas is formed using filler joists spanning between loadbearing masonry walls and/or downstanding steel primary beams (see figure 5 for an indicative sketch detail of this form of construction). The primary steels span into loadbearing basement internal/perimeter masonry walls.

At areas without a basement underneath, the floor is assumed to be a ground bearing concrete slab.

The common room/lecture hall spaces to the north of the building are open plan with the only structure in this area being the loadbearing perimeter walls. The southern side of the building comprises smaller office space and features internal masonry walls (which house chimney flues) as well as steel column sections (see Figure 4) which are embedded within partition walls. The

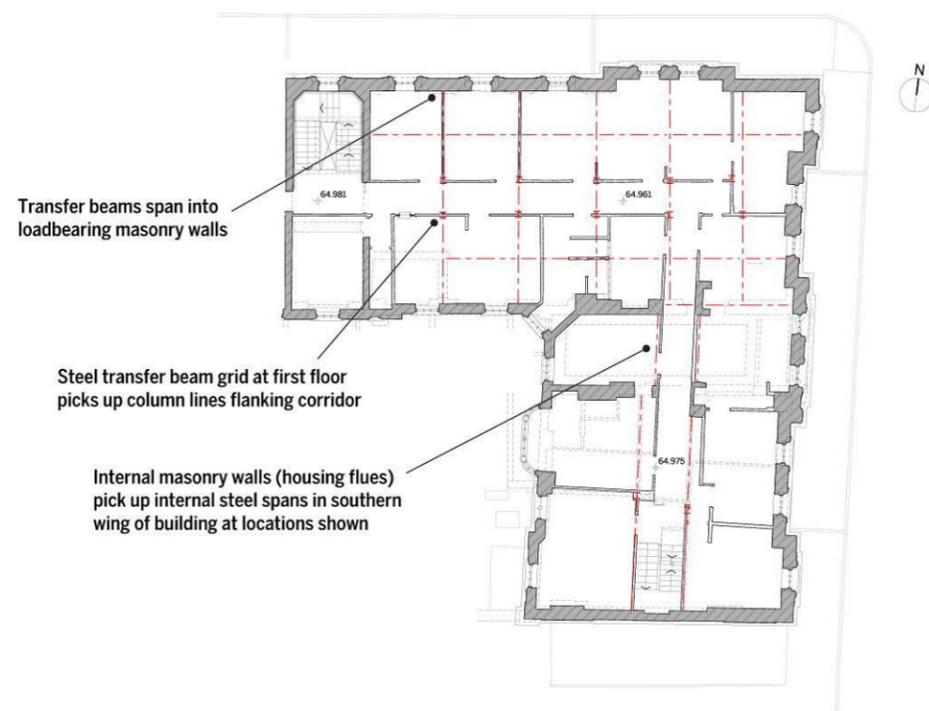
Figure 6 First Floor Schematic

In the southern wing of the building the orientation of the steel primary beams which pick up the filler joist first floor is to be confirmed. The support conditions for these beams appears to vary throughout this wing due to the presence of two internal loadbearing masonry chimney crosswalls, two steel internal columns in addition to perimeter loadbearing masonry walls. The assumed locations and orientation of the primary steels and filler joist infill are shown in Figure 6.

The northern wing of the building is set on a more regular grid with steel columns at approximately 3.0m centres flanking an internal centrally-running corridor. Column sections are embedded within the assumed hollow block partition walls and as such the section shape and size are currently unknown. To create the open plan common room/lecture hall space at ground level, these columns are picked up on a large grid of downstand beams which transfer all vertical loads back to the perimeter loadbearing masonry walls as shown in Figure 6.

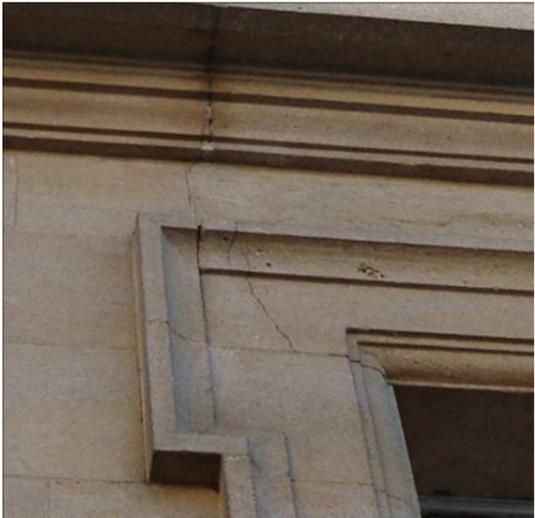
1913 Ruskin Building	Site Photograph	Element Condition	Additional Comments
Front Façade Stone Lintels

<p>Minor cracking is present at the bearing of a single stone lintel on the eastern façade. This cracking appears to be isolated to the location shown and is of no structural concern.</p>	<p>The cracking may have been due to slight rotation resulting from the loadbearing nature of the lintel, to the minor joint opening of the stonework above which may have translated into the lintel or to localised movement of foundations.</p>
Front Façade Brickwork

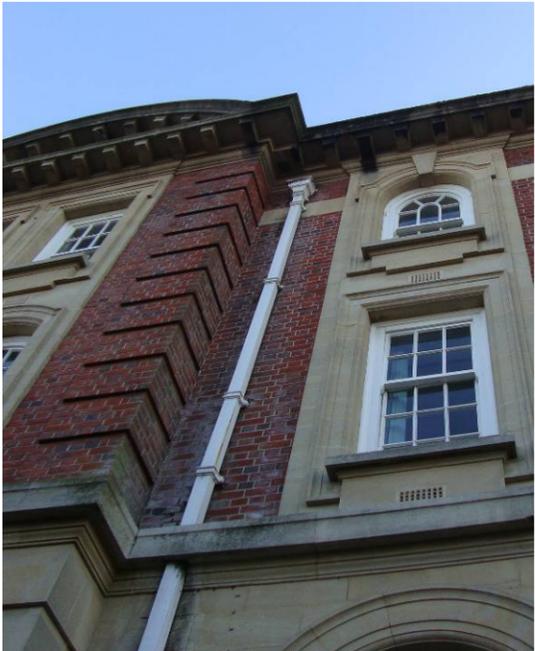
<p>The brickwork throughout the front facade generally appears to be in good condition.</p> <p>Efflorescence is present at a number of locations close to downpipes and where high level perimeter guttering has failed/become blocked.</p> <p>Penetrations are also present at discrete points within the brickwork due to the lack of repair works undertaken following fixings (e.g. for downpipes) being removed.</p>

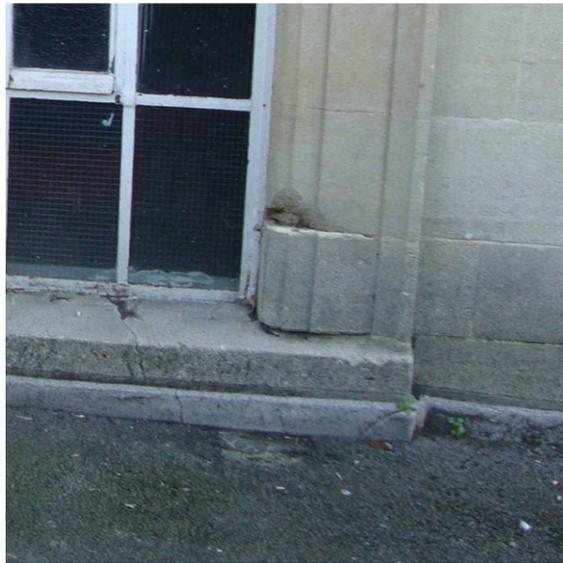
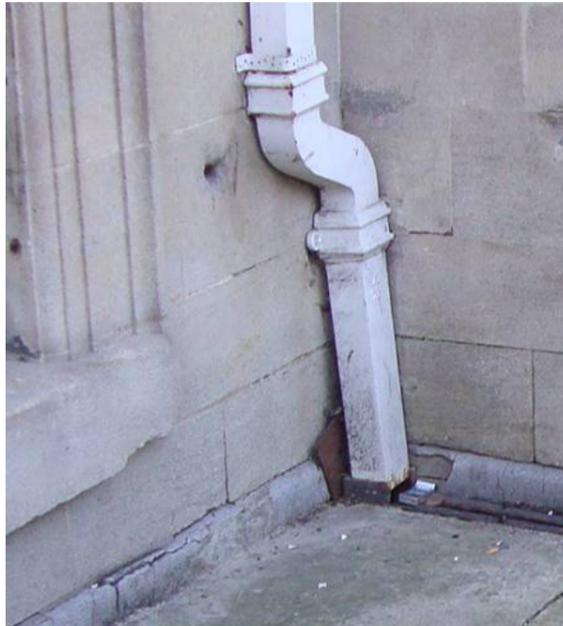
Front Façade
Stonework

The stonework generally appears to be in good condition.

Where stone is exposed (e.g. at outstands – especially at low level), edges locally are worn and subject to minor spalling.

Some staining is visible adjacent to downpipes.

A small penetration with associated spalling (resulting from a previous fixing directly into the façade) is also present within the stone at a single location on the northern façade.

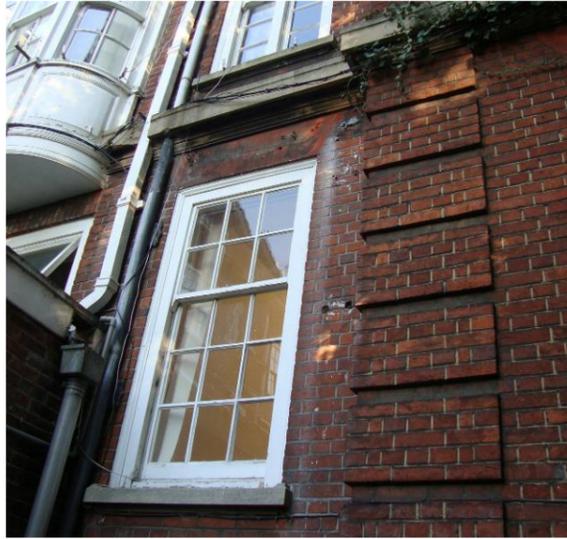
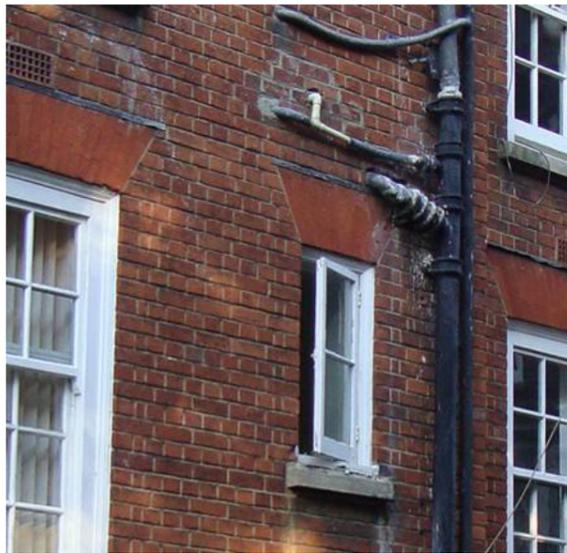
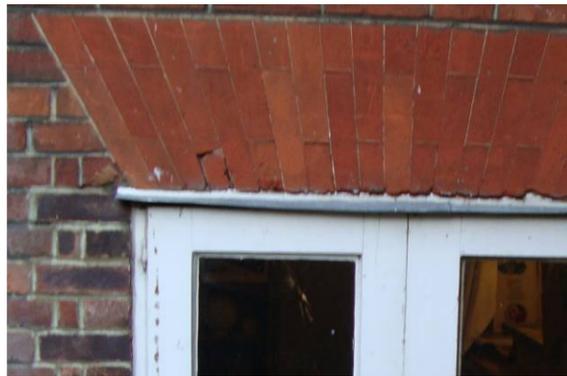
Rear Façade
Brickwork

Generally the brickwork is in reasonable condition.

Efflorescence is more prevalent over the rear façade due to the larger number of downpipes which are fixed to it.

Exposed penetrations are also present at discrete points within the brickwork due to the lack of repair works undertaken following fixings being removed (e.g. for downpipes).

Localised patch repairs have been undertaken following the installation of modern services connected into the downpipes on the façade.

A single brick within a flat arch lintel at ground level has cracked and started to spall where its edges are exposed

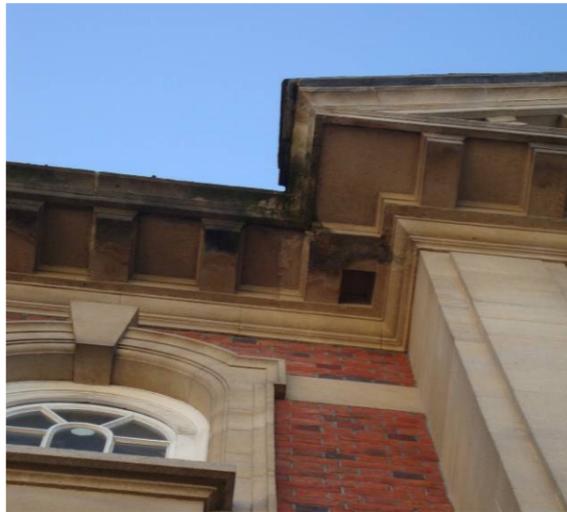
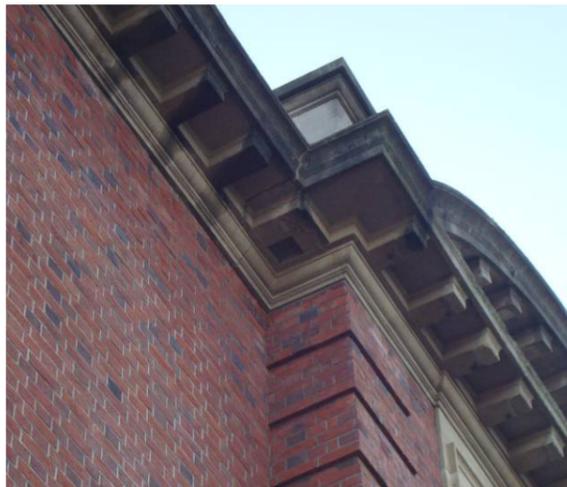
Perimeter
Coping

Coping stones running along the perimeter of the building are generally in fair condition although a number are stained due to presence of water within the perimeter gutter that may have leaked or overflowed if blocked.

The moisture present within the gutter has allowed vegetation to grow within the joints of a number of the stone leading them to open up and displace relative to adjacent stones.

A small number of the dentils have spalled at their edges.

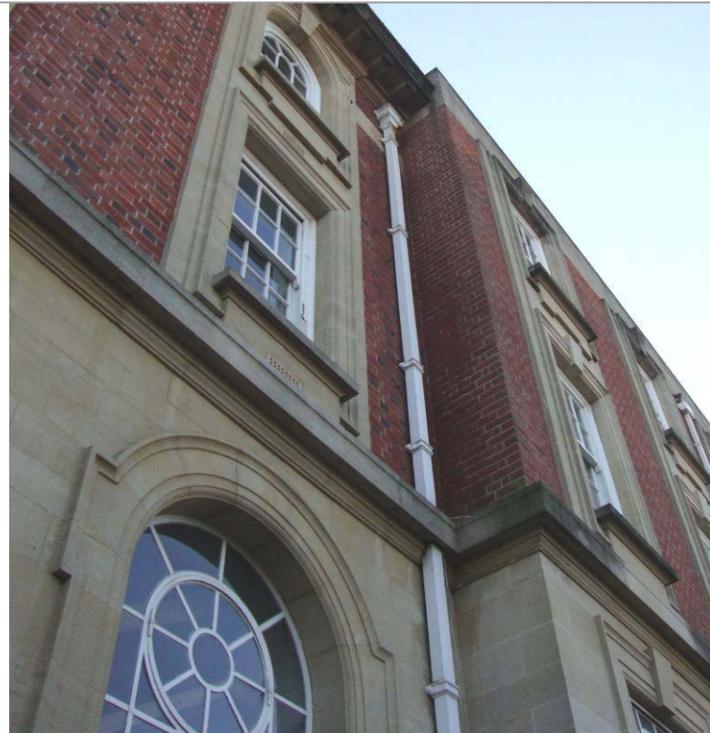
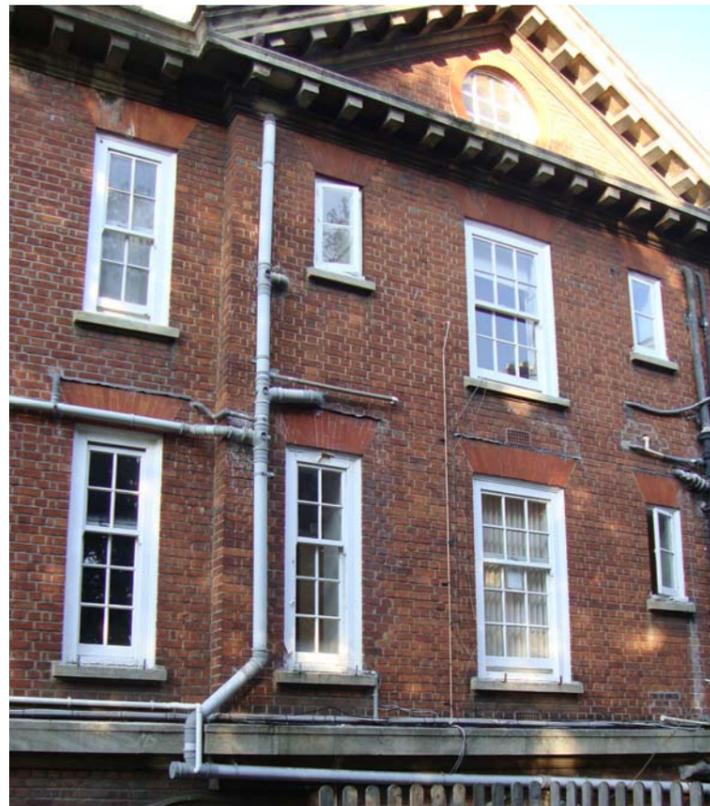
Tie-in between 1930's and 1913 building

The 1913 Ruskin building was extended to the west in the 1930's using an identical structural form. The extension is keyed directly into the existing masonry facades to form a single homogenous skin.

The interface between buildings is clear on the northern side as the 1930's building sits proud of the original by approximately 450mm.

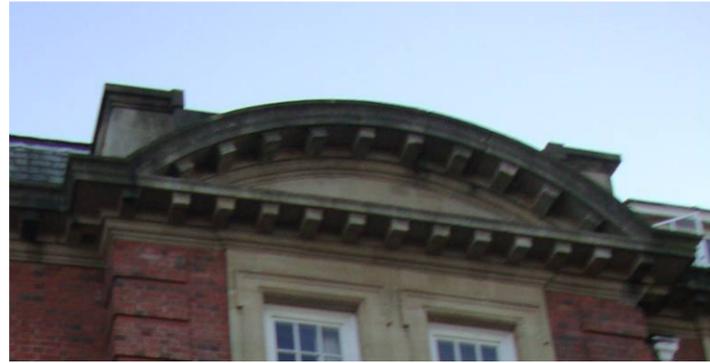
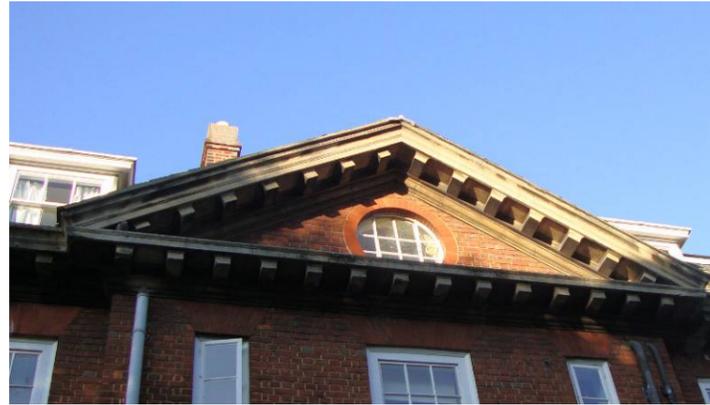
Pediments

Three stone pediments feature on the building. The stonework generally appears to be in good condition. The very edges of the pediments (directly adjacent to perimeter coping) are subject to the similar staining as the perimeter coping.

The base of the pediment on the rear façade has a small amount of vegetation growing on the surface with a minor crack on the east side.

The triangular pediment on the northern wing of the building was built with the 1930's extension. The exact alignment of the interface of these two buildings on the southern façade is not immediately clear. It would appear that this pediment straddles the two ages of construction suggesting that it is a later addition.

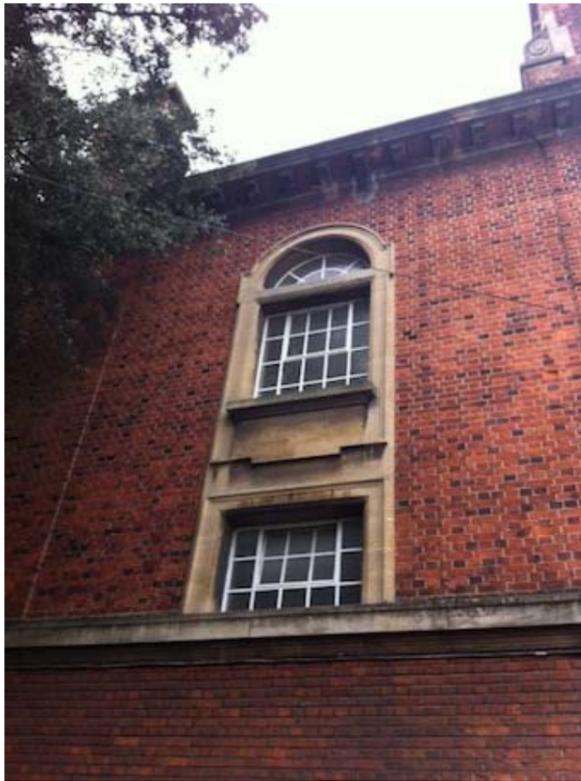
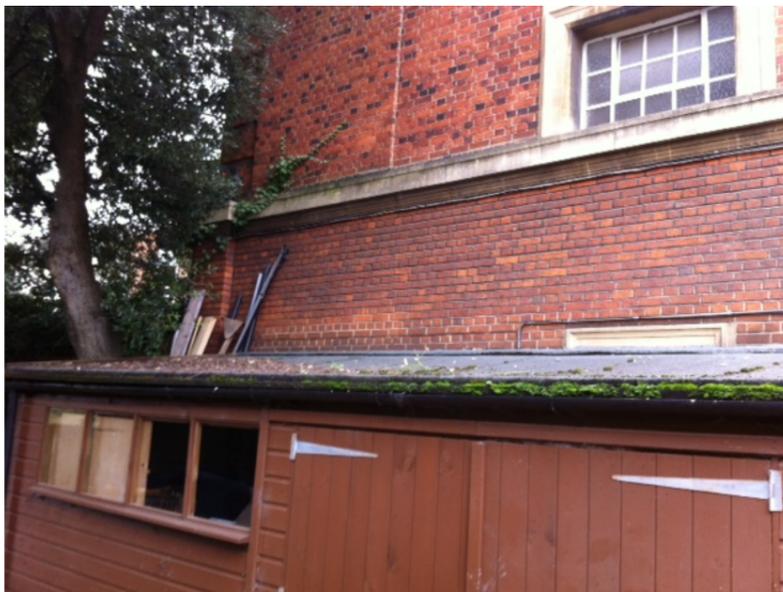
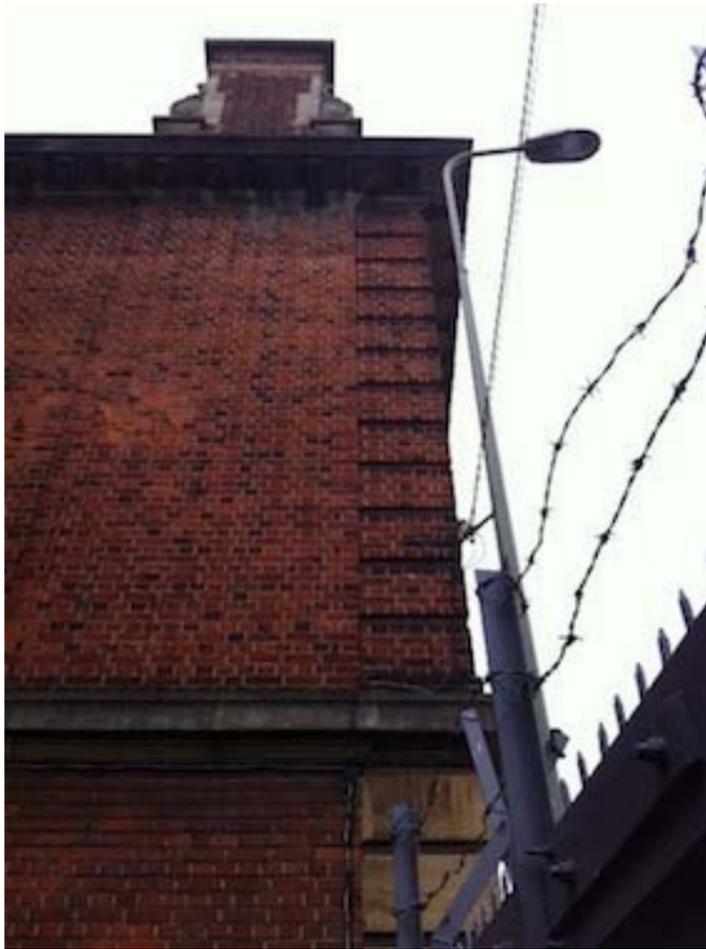
Gable End Wall to 1913 Ruskin Building

The brickwork has at some stage been re-pointed using a cement mortar, presumably over the original lime mortar. There is an area of spalled brickwork approximately 600x600mm at 2nd floor level which has considerable frost damage. Below first floor level stone cornicing, the brickwork appears to be a different type to above cornice level and is masked in large parts by Worcester College's materials shed which abuts the wall. The window opening at this level is also blocked off by this shed, and therefore condition of the wall at this lower level is unclear. There is some salt staining below eaves level stonework.

The condition of this wall is variable, and mortar joints unsympathetically re-pointed in cement mortar.

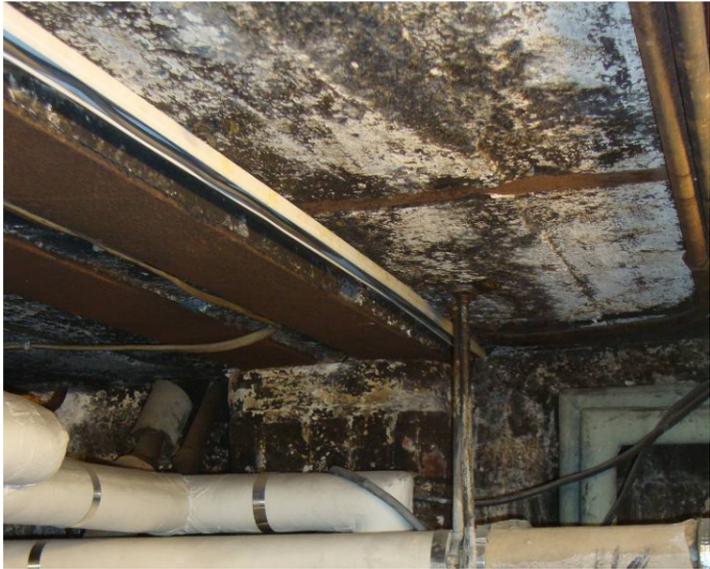
<p>Floor Construction (Basement Plant Room – northern wing)</p>

<p>Steelwork is visible at two locations, both within basement level looking up at ground floor.</p> <p>At one location, primary steel beams span between basement masonry walls and pick up a masonry wall above as well as a filler joist floor. These steels are doubled-up I sections with bottom flanges exposed. The filler joist floor spans into this main beam and contains smaller I sections at 3' centres with clinker concrete spanning between.</p> <p>The condition of masonry at locations of beam bearing is poor.</p> <p>The condition of the visible steelwork (lower flange) is uniformly rusted with signs of spalling at the edges of the flanges throughout.</p>	
<p>Floor Construction (Basement – southern wing)</p>

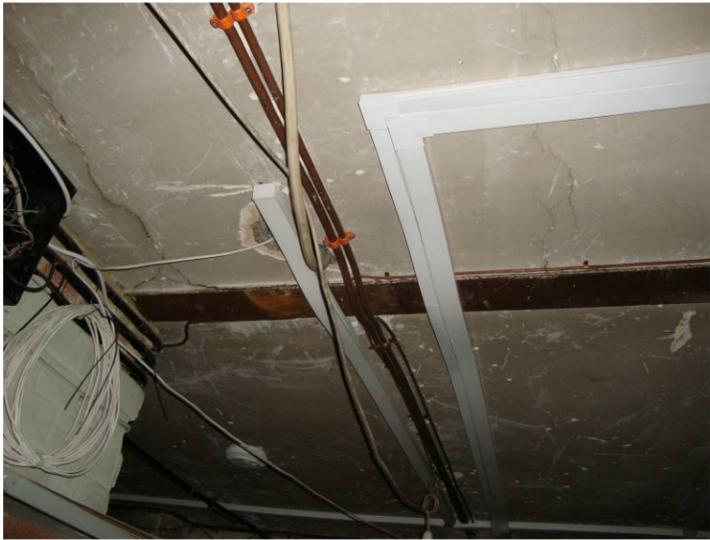
<p>A single steel ground floor beam is visible from basement level in the northern wing of the 1913 building. Similarly to the location mentioned above, this beam loads directly into masonry walls on either side.</p> <p>The visible areas of the beam (bottom flange) are uniformly rusted. The filler joist floor has generally been plastered over although small areas remain exposed during post drilling of service conduits.</p> <p>Concrete encased steel downstand beams are also visible within other rooms in the southern wing. A masonry corbel detail is used at one location to reach out and pick up the beam. It is unclear why this is not built into the wall as appears to be done at other locations.</p>

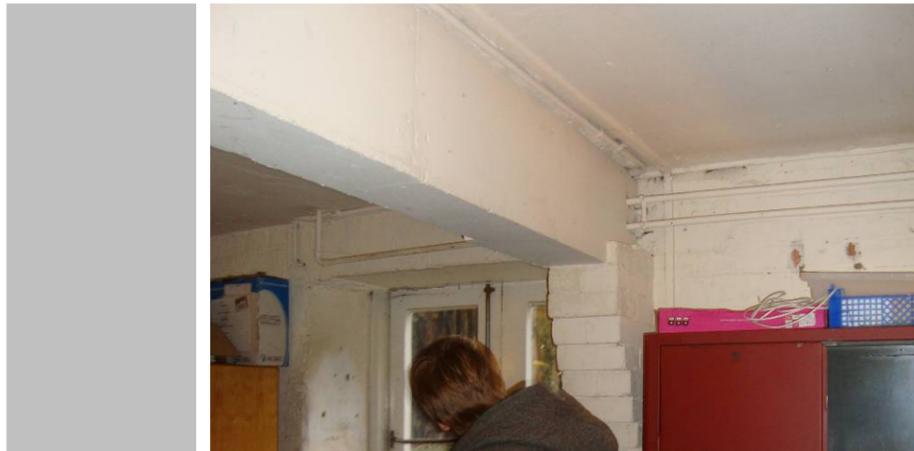
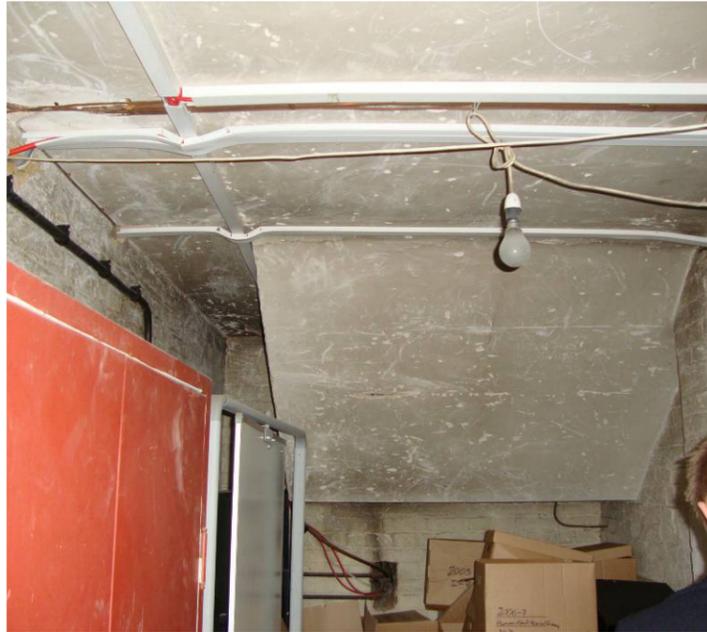
Stair Access to southern wing

Stair access was required between original lobby level and the ground floor of the southern wing. The concrete stair structure cuts into the loadbearing walls below as shown on the adjacent image. As the lobby level has been raised from its original standing, these stairs have been infilled/framed out but still remain underneath.

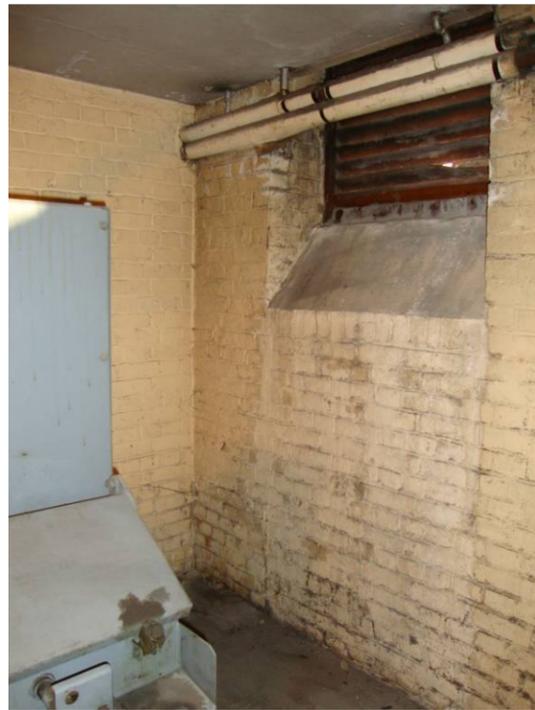
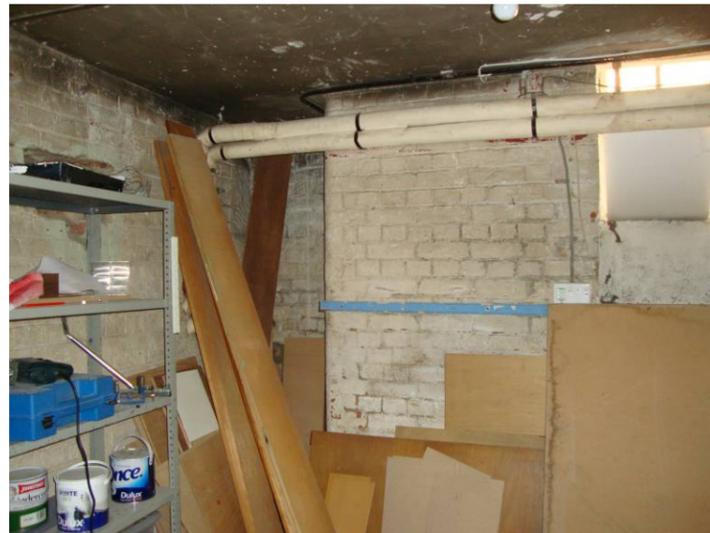
Basement Retaining Walls (southern wing)

Basement retaining walls are formed in loadbearing masonry. They appear to be in reasonable condition.

At the base of return locations within the electricity sub-station there are signs of localised damage.

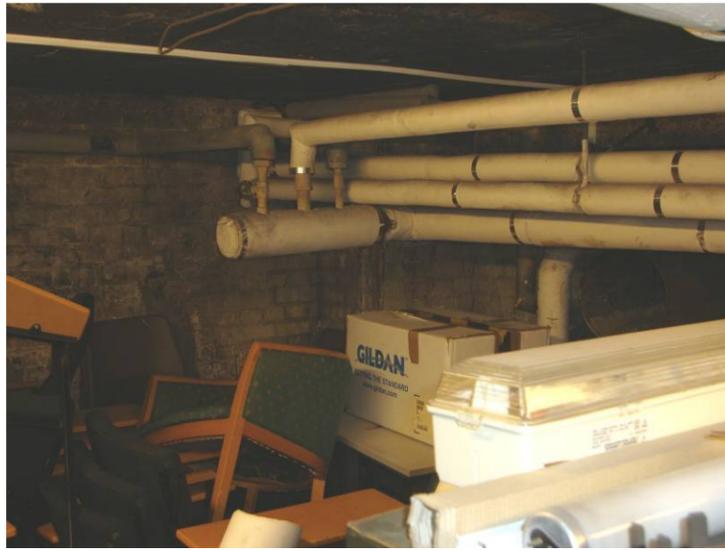
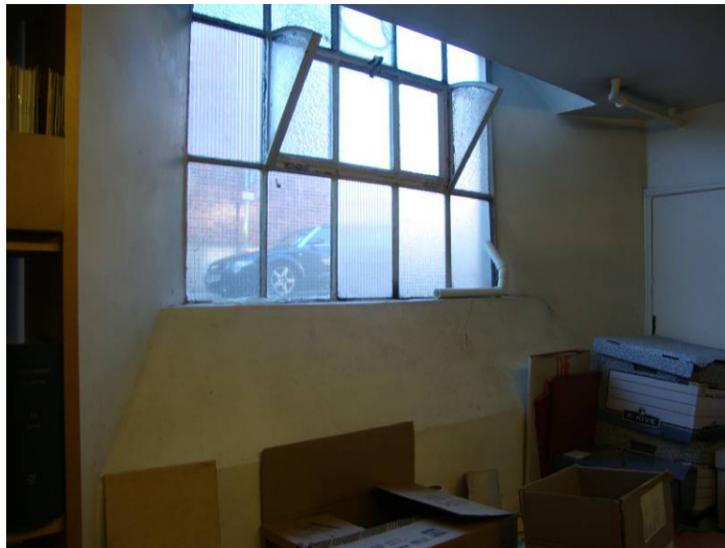
Basement
Retaining Walls
(northern
wing)

A plant/boiler room is present on the western edge of the northern wing of the building. This is shared between 1913 and 1930's buildings (it is to be confirmed whether the whole basement space formed part of the original 1913 scheme).

The retaining walls are formed in masonry with no visible signs of damp throughout. Penetrations are made through the walls have been roughly cut with loose and cracked bricks in the immediate vicinity of the hole.

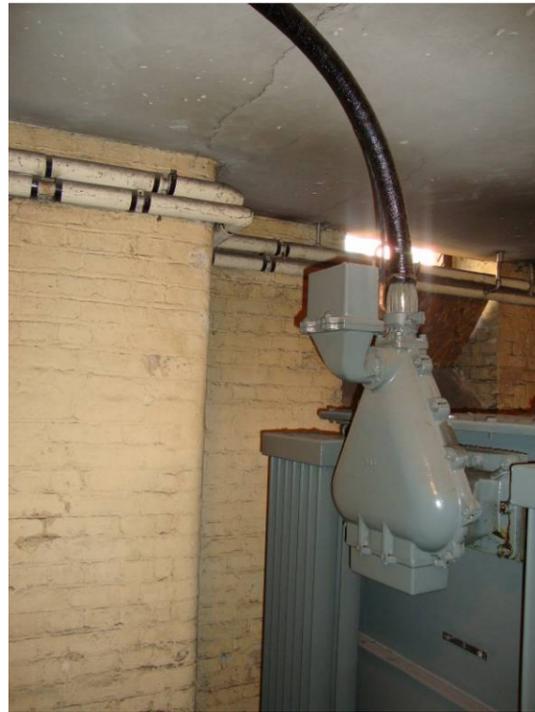
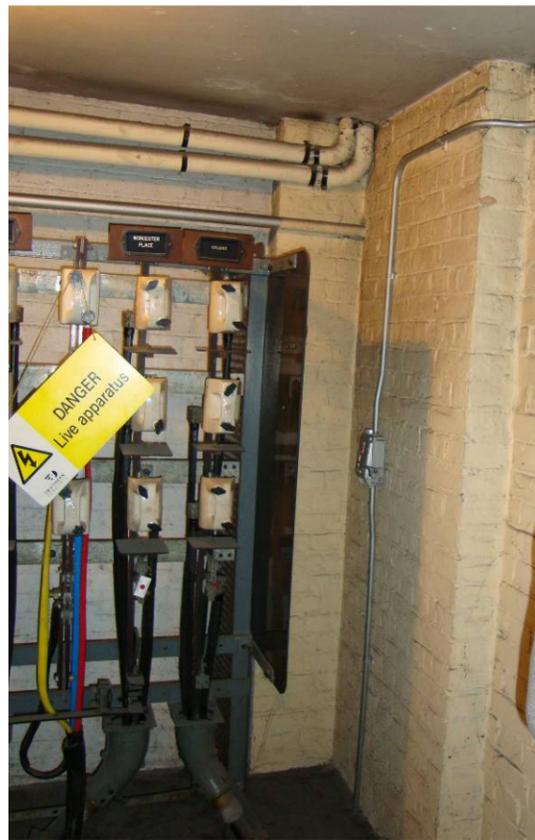
Substation

An electricity substation is present within the basement under the southern wing adjacent to the pavement. It has been suggested that this was installed in 1950's (tbc)

Access to the substation is solely via the Ruskin Building southern internal staircase.

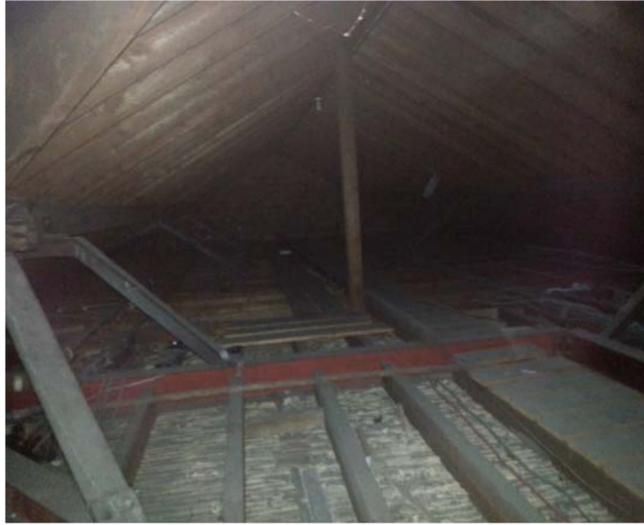
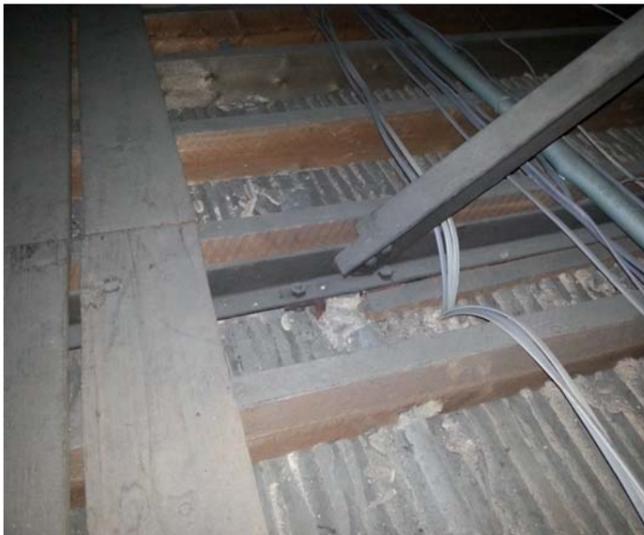
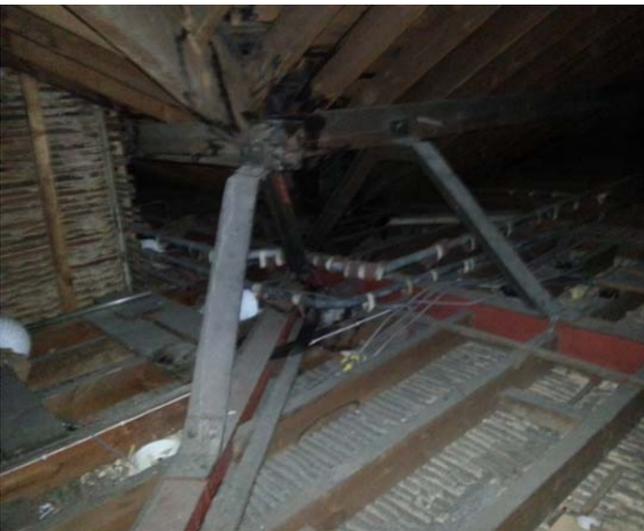
Roof Structure
Original Ruskin
Building

The roof structure is formed from timber rafters picked up on triangular steel frames located either side of the corridor walls, the structure appears to be in good condition overall.

There is one area where there is a bit of damage along the ridge line caused by water ingress this can be seen in the third image here.

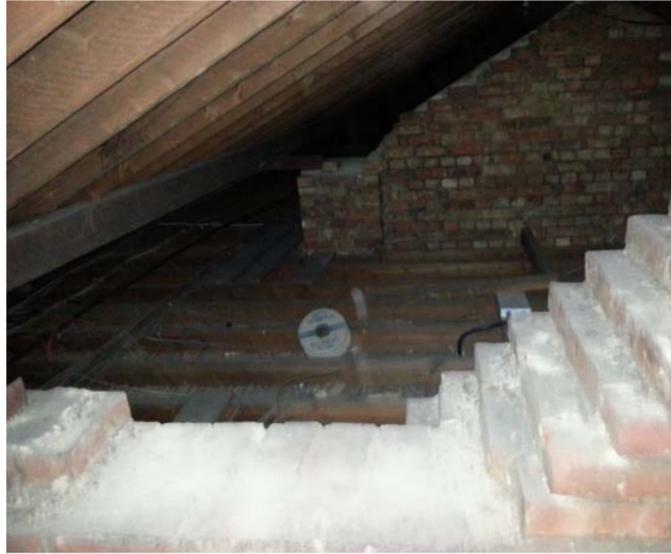
Chimneys
Ruskin Roof

The original Ruskin roof space houses the chimney stacks and provides the location where they traverse from one side of the corridor to the other. These are in good condition.
