EXETER COLLEGE OXFORD

A New Quad at Walton Street
Bat Survey Report

March 2013

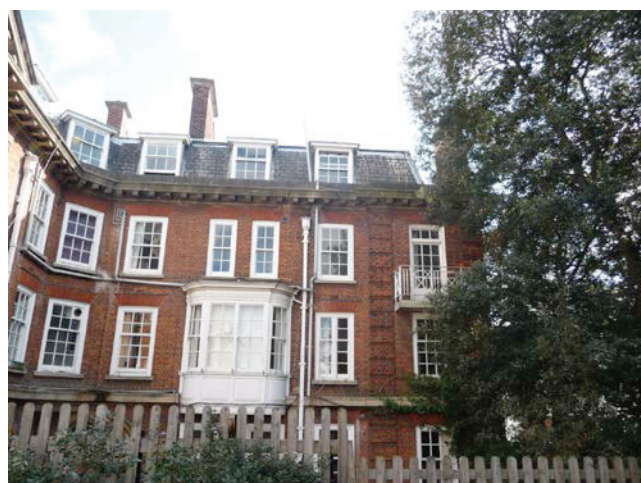
Fig. 1 west elevation, most weaknesses were present in the protective coverings (flashing, tiles etc) found at the curve of the building (Fig. 3).

There were regular points where lead flashing was no longer flush to the tiles or window framework, either through lost pins or where they had been subject to past repairs. The vents were open and not covered by chicken wire and could theoretically allow mammal access. There were no collections of bat droppings splayed on the walls or urine stains on the windows (windows were not routinely cleaned, useful for survey purposes).

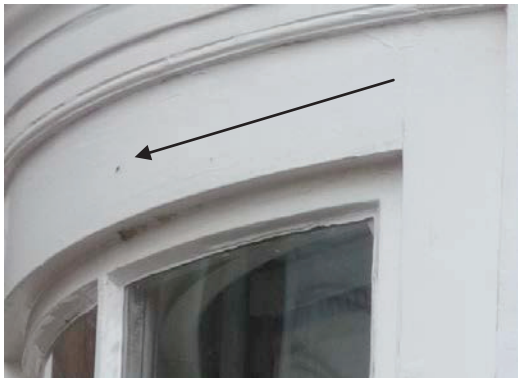
The west elevation had a Queen Anne style window (the Principals office) where a possible bat dropping was found (refer to Fig 2 below). This was the only mammal dropping noted during the survey and could not be reached for further analysis. Many pigeon droppings were noted, especially under rainwater goods, which served as perches.

Fig. 2 The arrow marks position of a dropping on the window of the Principals office. Flashing pins above this window were often missing.

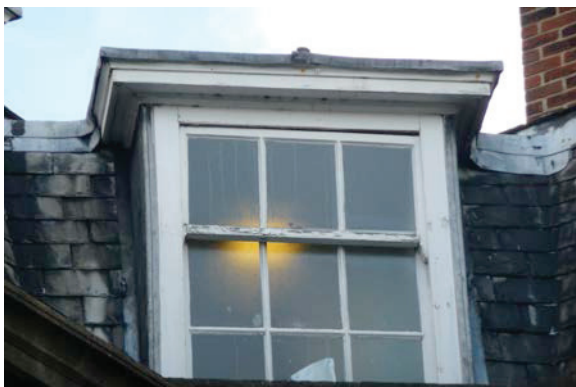
Fig. 3 note deep gaps in flashing on the roofline

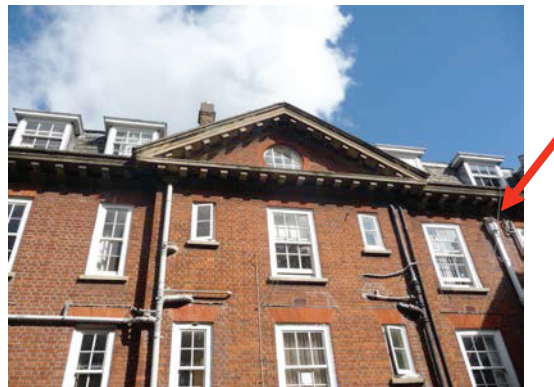
Fig. 4 southern elevation note nesting birds

A pair of great tits *Parus major*, were noted nesting within the top of rainwater goods (red arrow at Fig. 4) to the east of the pediment on the southern elevation (see law pertaining to nesting wild birds at 5.3). The weaknesses in protective covering were repeated at this elevation, although some cracks in brickwork had been filled in with sealant. This aspect of the building was the most favourable for mammal potential due to its warmth. A linking building between the main building and a concrete dining block, housed the stairwell. This had a loose wooden fascia board, although no additional weak spots were

Birds are using the building and grounds and they are protected when at their nests see 5.3.

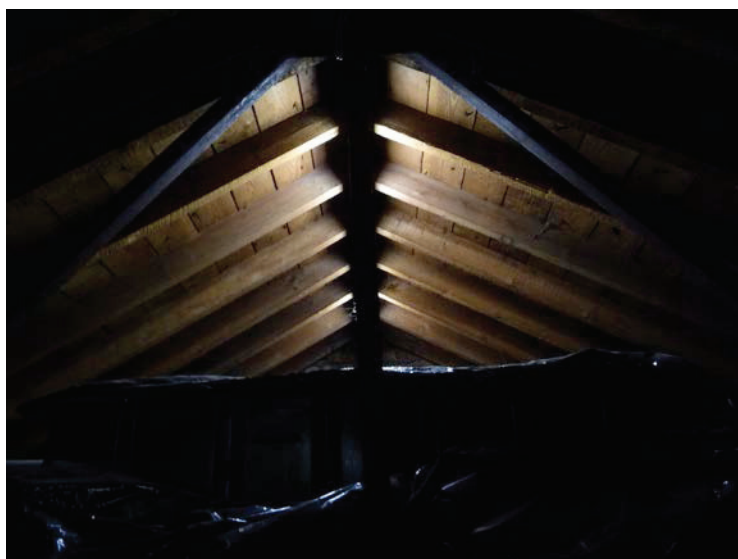
Fig. 5 Loft view west

The loft is in two parts separated by a fire wall. The Walton street side is difficult to access, through a door, which can only be reached by placing a ladder in a bath. The Worcester Place loft is straightforward, although disposable protective clothing

should be worn on account of scattered squirrel poison, widely distributed around the boarded floor. The loft space is clean, has electricity, lacks any insulation material and the water tanks are covered. The hatch is disguised as a ceiling tile and can be accessed from outside room 3.16. A cursory inspection did not reveal any bat droppings or hanging animals.

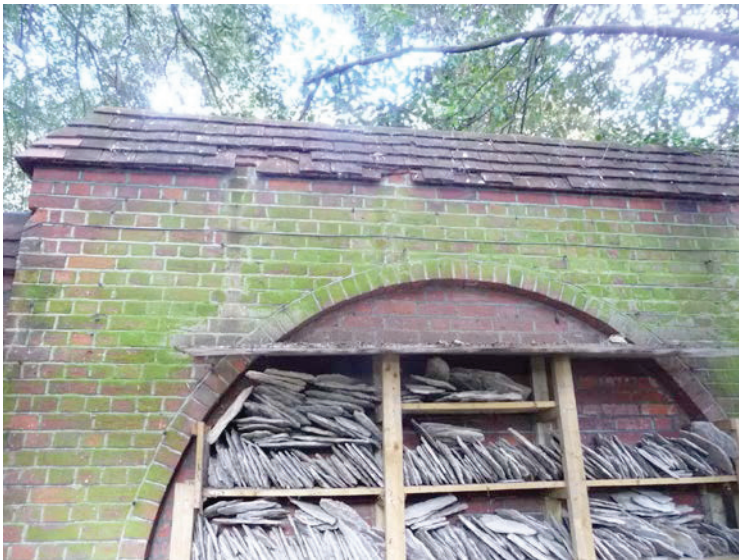
Fig. 6 Boundary wall
Access was gained to view the offside of the wall, where many broken tiles were noted. Due to the aspect and covering of vegetation it is possible that bats may use this feature from time to time on a casual basis. The patio garden may be used by nesting birds.
