EXETER  
COLLEGE  
OXFORD

A New Quad at Walton Street  
**Ruskin Building Structural Intervention Statement**

March 2013

**Exeter College, Oxford – Walton Street Site  
Structural Interventions to the Ruskin Building**

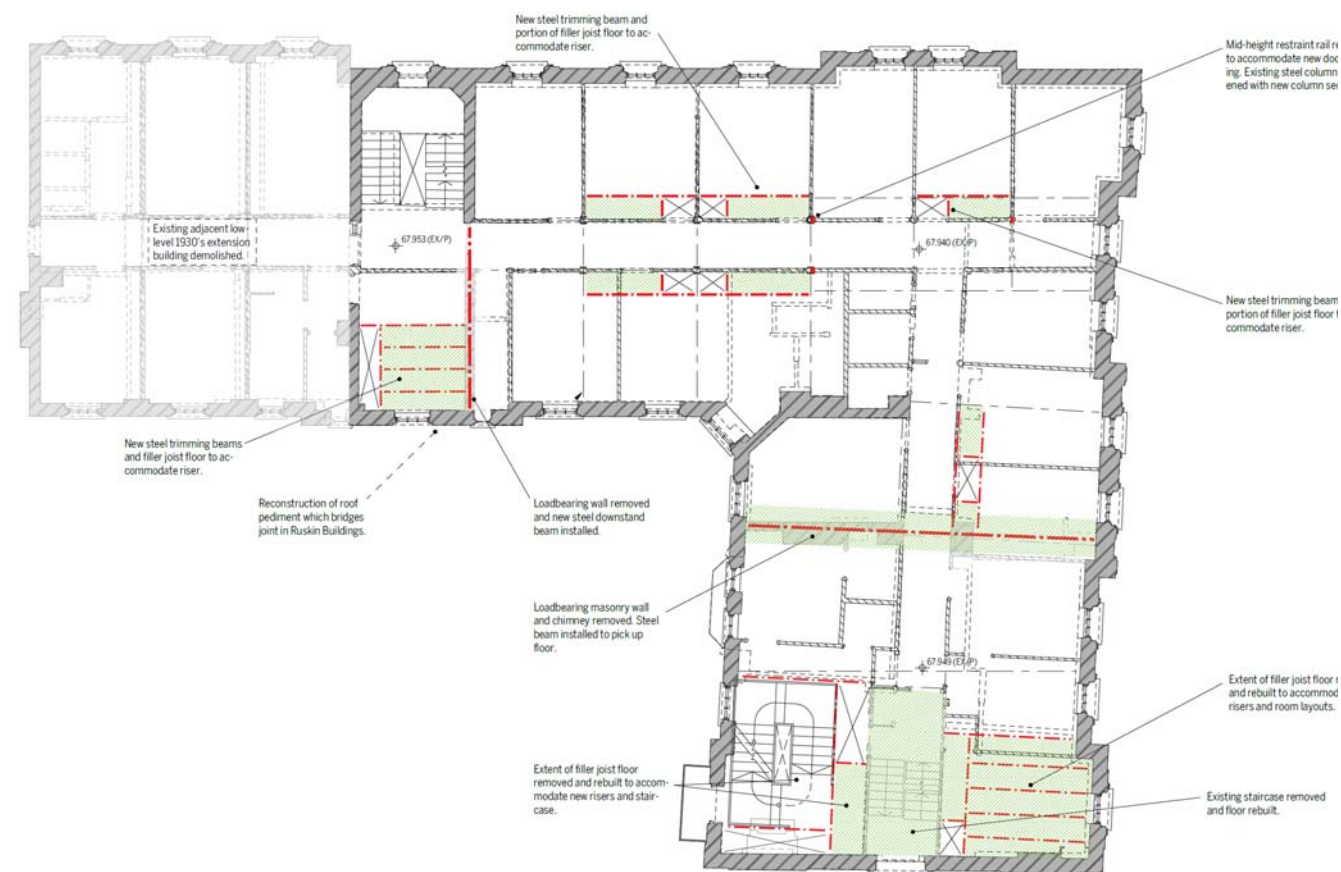
**Figure 2: Ruskin Building Typical Upper Floor Intervention**

The existing corridor walls have steel columns buried within their depth. These columns are laterally restrained by mid-storey height horizontal rails. This structural arrangement constrains locations of door openings and risers. Where doors into bedrooms and riser locations can't be accommodated within this current structural arrangement, the horizontal steel rails have to be removed, and the existing steel columns stiffened with supplementary vertical structure resulting in larger column section size.

The corridor clear width between steel columns is typically 1245mm, which is below 1500mm minimum clear width required by current Building Regulations Part M. Retaining the existing steel column arrangement would therefore result in compromised layouts non-compliant with Building Regulations.

Filler joist floors are locally re-constructed to accommodate service risers and the new stairwell at the Walton Street gable end. The extent of reconstruction is shaded green on the following plans.

A major structural wall with chimney stacks within the Walton Street wing, running from front-to-back, is to be removed. Floor structures will have to be locally re-supported with new steel downstand beams and local making good of floors. The temporary works required will need carefully designing and installing, with the sequence of works starting from roof level downwards.

To provide enough floorplate depth from front façade to rear façade in order to accommodate DDA compliant bedrooms, adequate bathroom provision and insulation to the existing walls to comply with thermal performance criteria in Building Regulations Part L, the rear façade would need moving back by circa 500mm. The works described in this section retain the rear façade, resulting in a compromised, non-compliant Building Regulations proposal.

These works at first floor, and upper levels generally, are significant and very intrusive, and result in a compromised arrangement for corridors, student rooms, and non-compliance with current Building Regulations.

It can be seen from figures 1 and 2 that at all levels of the building it is necessary to re-construct the floor structures adjacent to this gable end. Given the temporary stability of the stairwell and gable end wall, serious consideration should be given to de-constructing both the wall and chimney stacks from roof level downwards, and re-constructing the wall and stairwell in its new location from basement level.

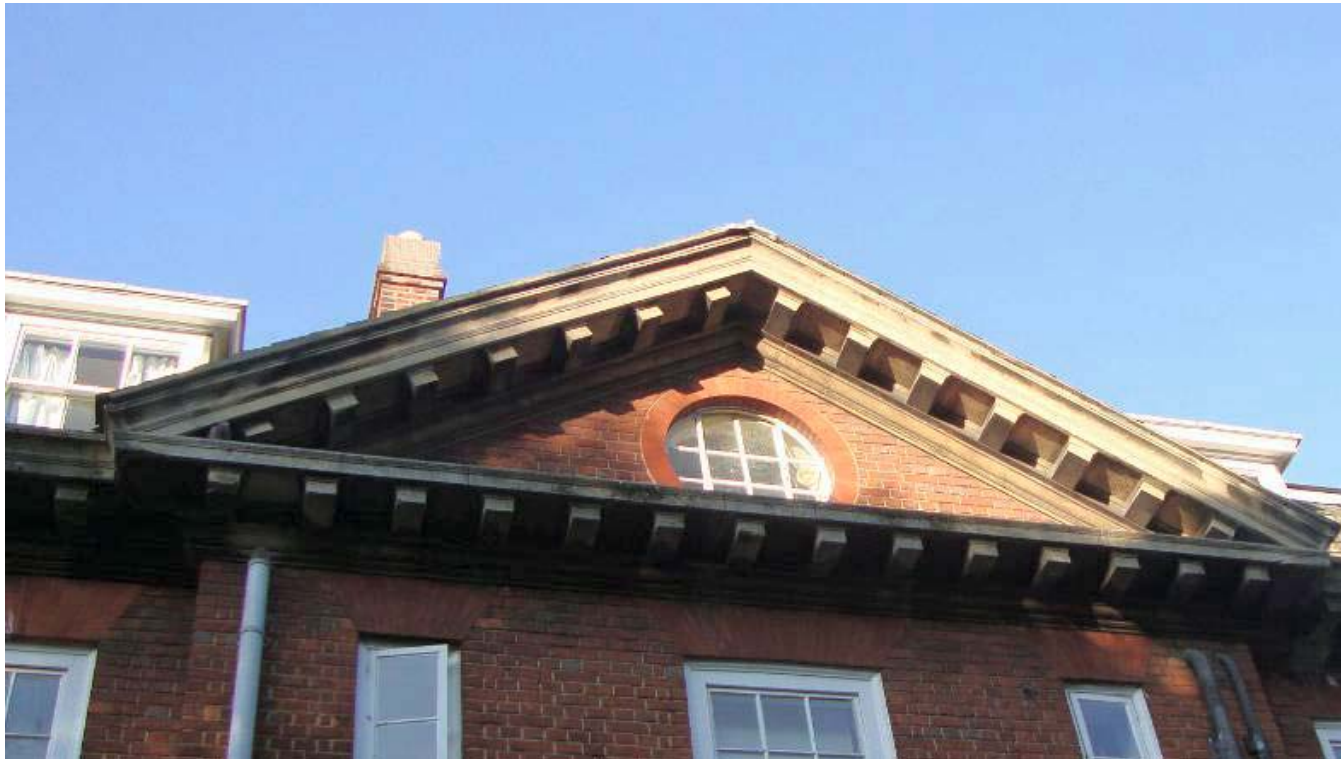
**Figure 3: Roof Pediment on internal facade junction between original 1913 Ruskin building and 1930's extension**

The rear elevation to the Worcester Place elevation, where the 1930's extension is toothed into the original 1913 building, has a pediment at roof level which abridges this interface. This would need to be carefully removed and the top of the brick elevation in this area, underneath the proposed eaves level, locally re-built.

Furthermore, the join between between the 1930's extension and original 1913 building is crudely toothed together and deviates in position down the building façade. Retaining the 1913 rear façade as existing and making good where it abuts the proposed extension block in this location is complex.

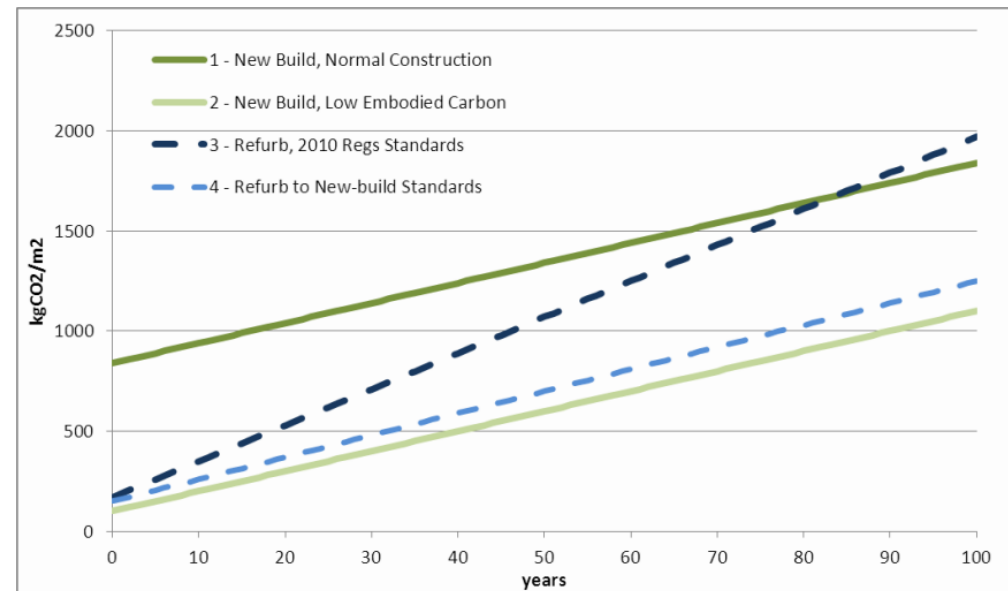
Figure 11: Embodied Carbon vs. Carbon in use

The following graph shows some example scenarios comparing the initial and future projected carbon emissions associated with new build solutions (solid lines) vs refurbished building solutions (dashed lines). The ongoing carbon emissions trends shown here are representative of the ongoing fuel costs, ignoring price fluctuations.

Option 3, which is equivalent to retaining the existing Ruskin Building structure, is clearly unsatisfactory as it is bettered by all other options in the medium-long term. Future legislative changes and fuel price increases will make option 3 even more inefficient compared to the other options.

Option 4, which is equivalent to retained front facades and re-constructed fabric behind, requires very careful control over all thermal bridging and gaps in the airtightness of the envelope. All existing thermal bridges are removed by creating an entirely new and independent support structure for the internal rooms, and a new internal lining. The highest standards of insulation and airtightness may still not be within reach without entirely overcladding the building from the outside.

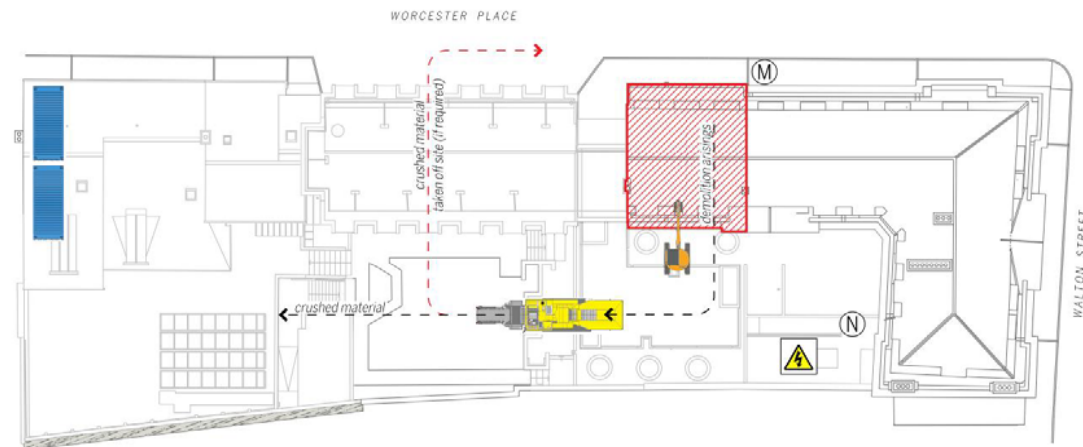
**MOVEMENT 6**  
Demolish 1930's Ruskin extension including facades. Grub out base slabs and foundations, and back-fill to piling mat level or cart off arisings as required.
