## The Ruskin Building

# 4.1 Building Condition

## 4.1 Building Condition

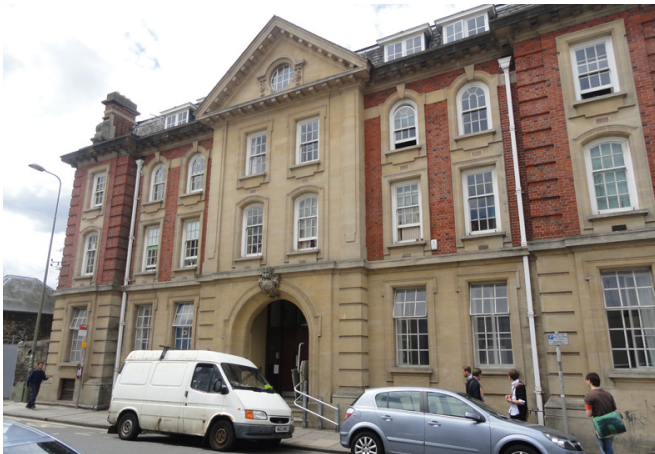
Walton Street Building View

The existing envelope consists of a load bearing brick work facade. The 1913 and 1936 buildings are made up of brick and stone with single glazed timber windows at upper floors and metal window frames at ground and third floors. The 1968 building is constructed of a reinforced concrete frame clad with precast concrete panels hung from each floor level. The fenestration consists of timber framed single glazed units within the pre-cast panels. The 1980s extension is formed of traditional load bearing masonry with timber framed double glazed casement windows.

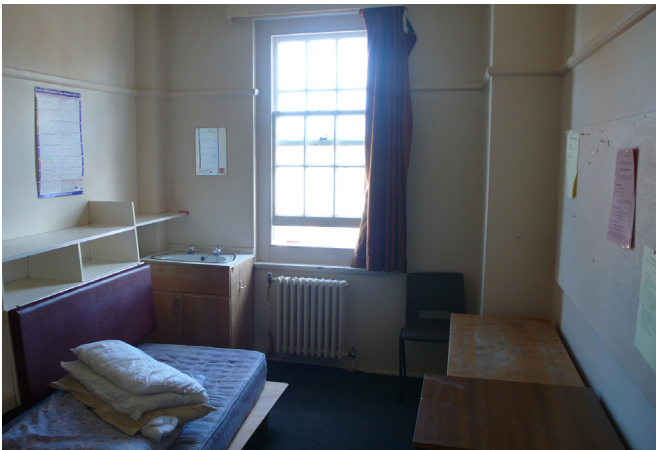
Smaller Student Bedroom

Due to the piecemeal approach to the extending of student accommodation creating, study and admin space the Walton Street site has serious problems with accessibility, it's associated functionality and future adaptability,

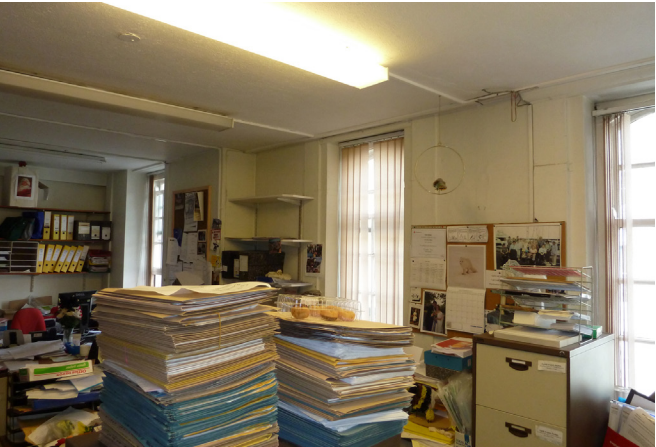
Existing Administration Room

Internally the building is a maze of interconnected corridors and with staircases and ramps. As such five sets of stairs have to be navigated when going from one side of the site to the other.

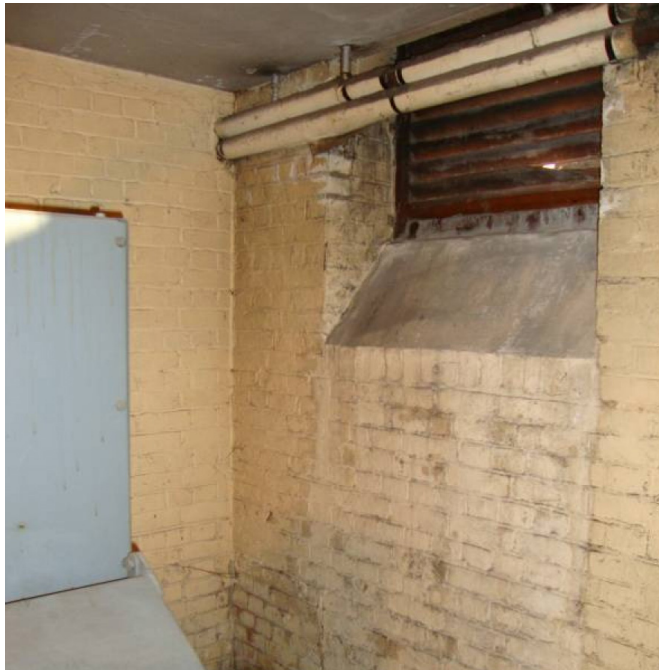
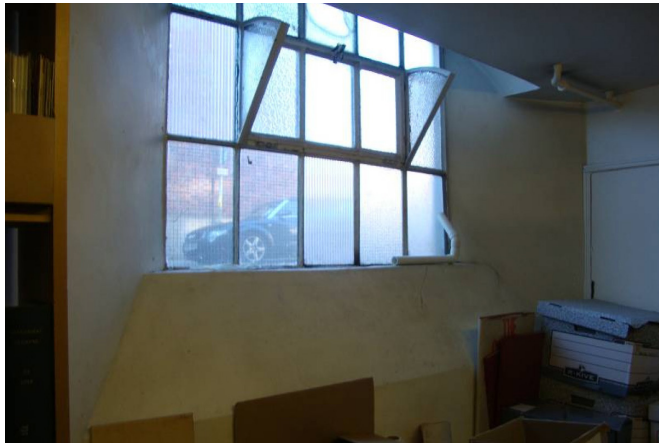
Basement Retaining Walls

The 1912 Ruskin Building is formed of perimeter load bearing solid brick walls (partially faced in stone), with a structure typical to buildings of its age. The perimeter facade walls support filler joists spanning between internal steel posts, which are concealed within the internal partitions. The third floor mansard roof is formed by timber trust rafters supported on the internal steel columns. There are a number of load bearing internal partitions, with steel beams to support the chimney flues. The perimeter walls are supported on brick foundations, with concrete footings.

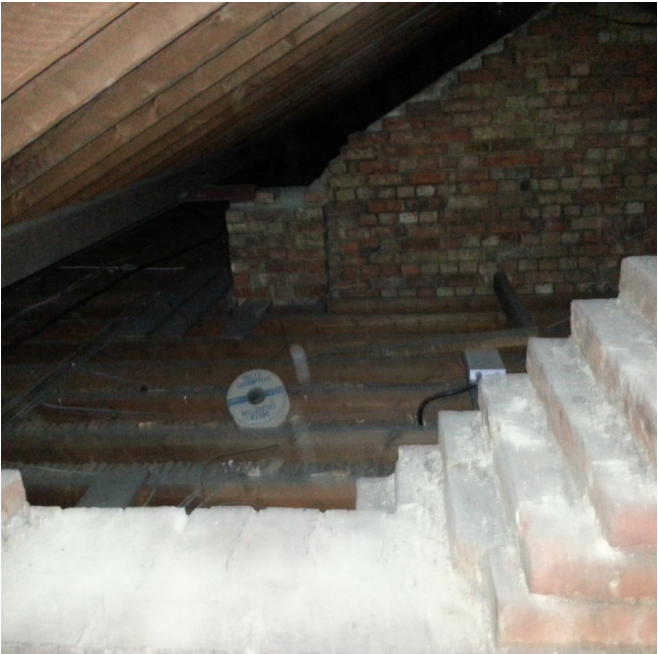
Chimneys in the Ruskin Room

Internally there are a number of down stand beams and a masonry corbel beam, where the primary steel beams are exposed there is uniform rusting. The internal arrangement of the floor levels, particularly around the porter lodge has been modified over the years, in order to accommodate the ventilation of the substation. There is some water ingress damage on the timber rafters supporting the mansard roof.
